# TOWER ASSESSMENT REPORT

PREPARED BY: MAC-TOWER INC  
15-1201 GRASSMERE RD  
WEST ST. PAUL, MANITOBA  
R4A 1C4

# **EVAPCO – COOLING TOWER 1**

## EVAPCO – COOLING TOWER 2

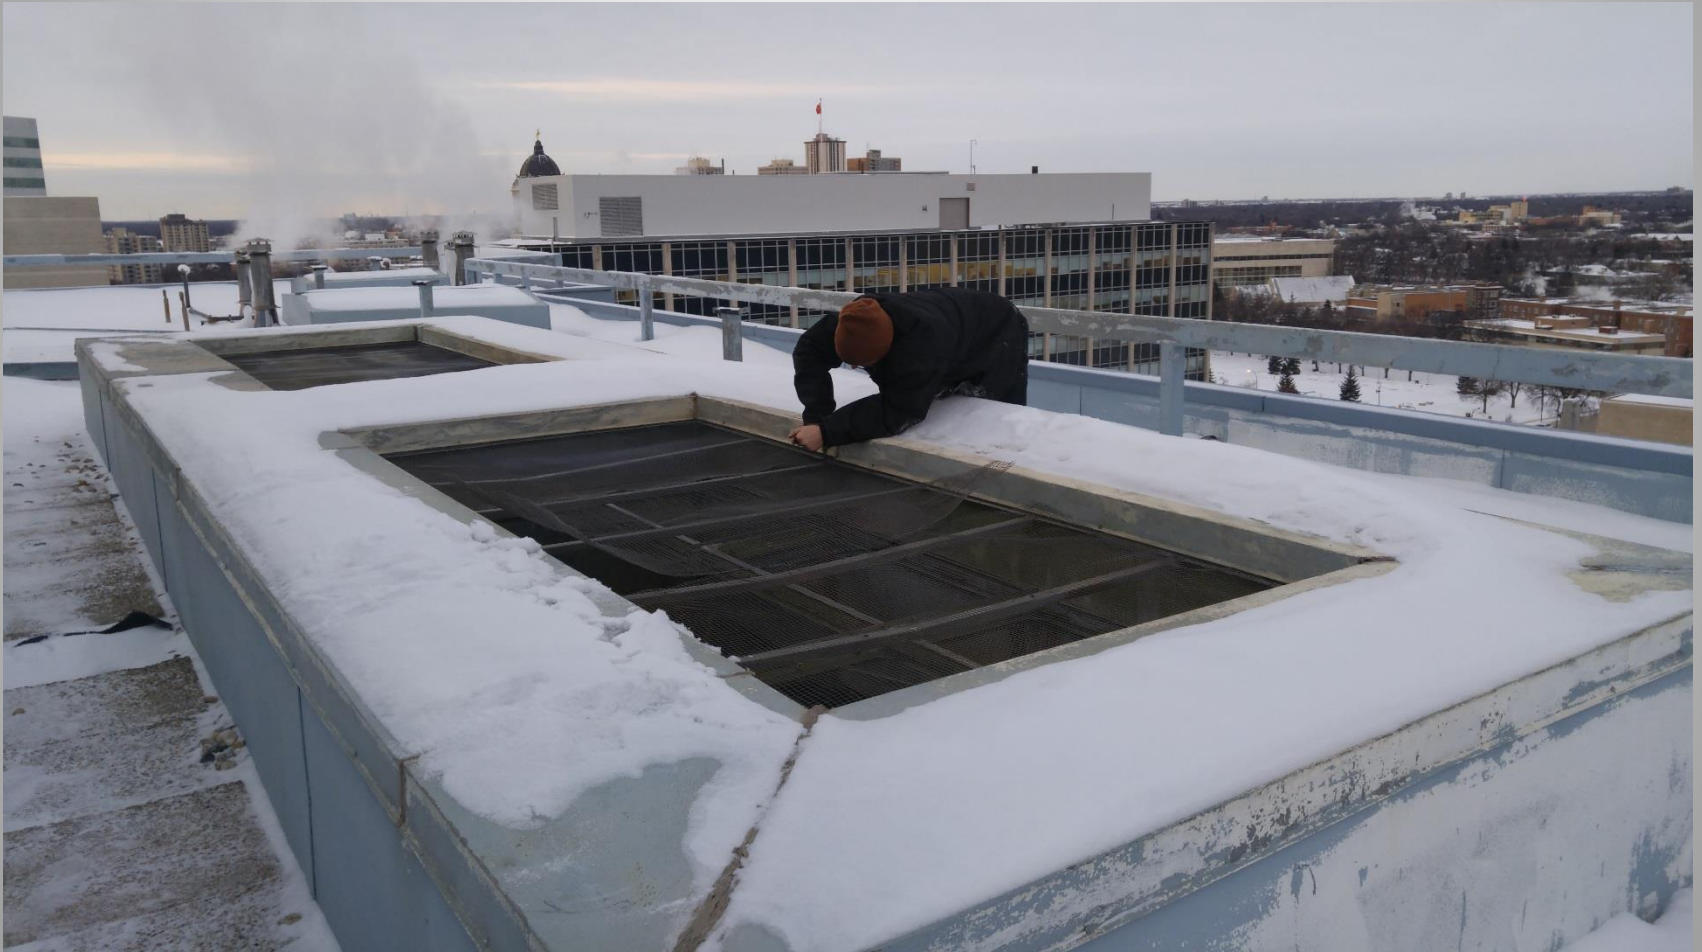
# Discharge Air Dampers

BOTH COOLING TOWERS MISSING DAMPERS. NO LOUVERS AND ELIMINATORS BROKEN.

- Clean or replace header section, and replace eliminators, fill and nozzles.
- Repair leaks at panel seams, bolts, and collars while fill and headers are removed for replacement.
- Replace discharge air damper section.
- Replace blower section.
- Evap-Line or replace entire cold water basin and install new strainer and supports.
- Replace electronic water level control.
- Replace sump heater and controls.

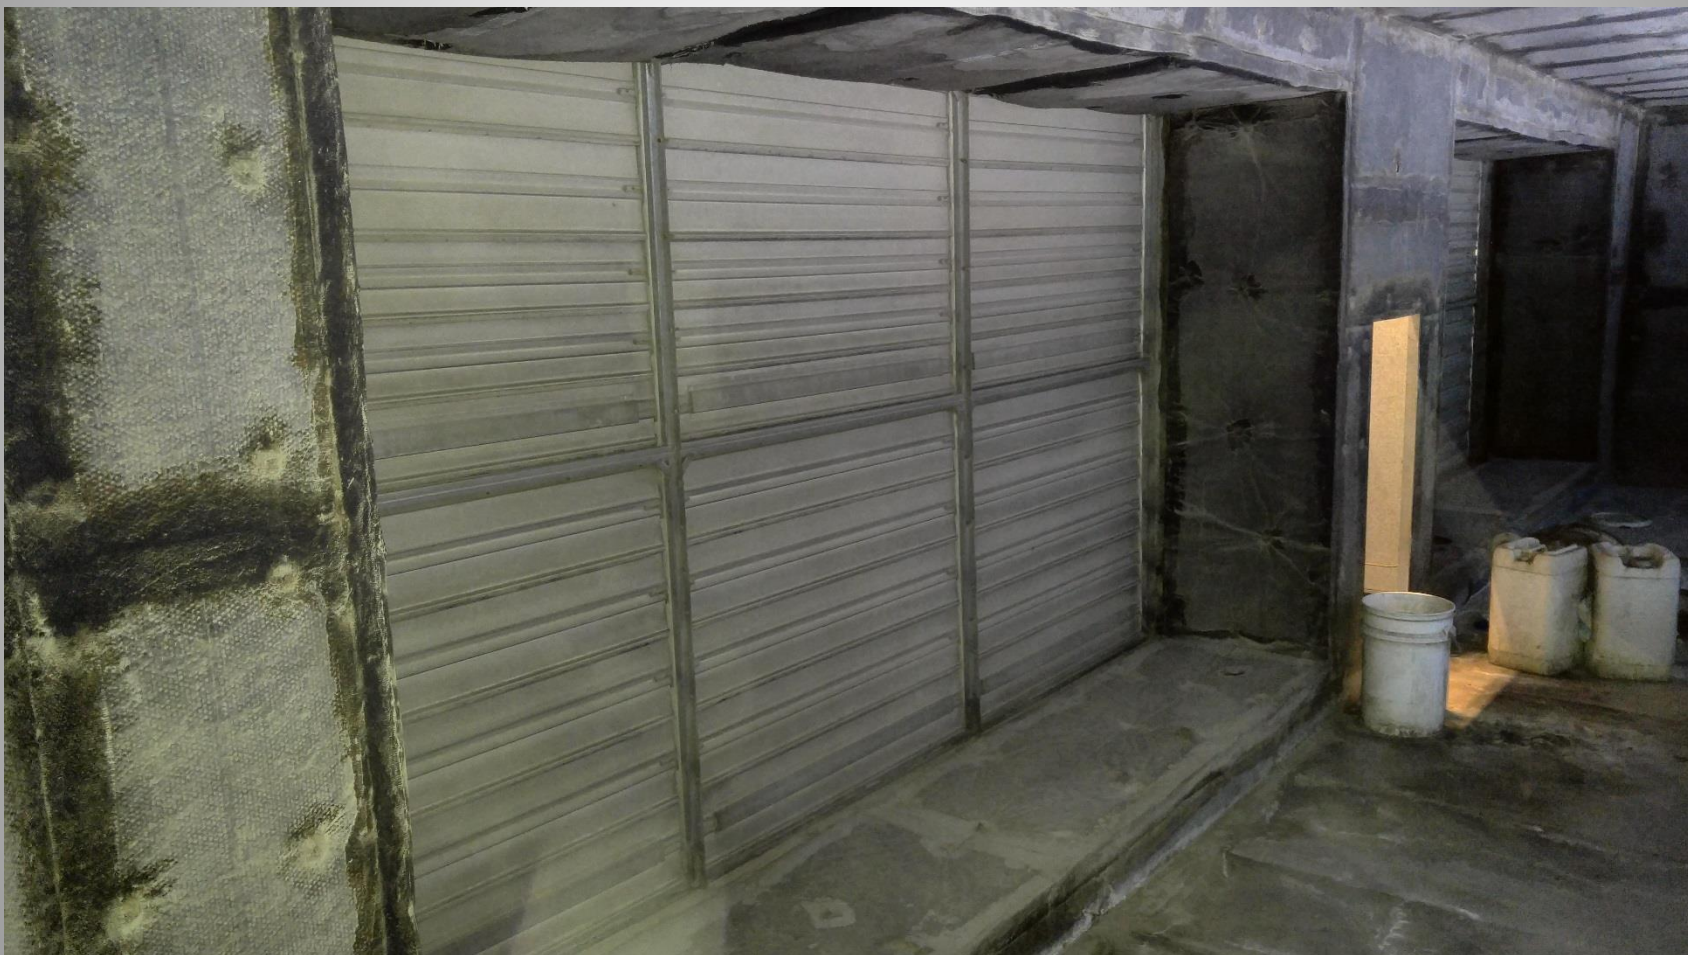
# INLET LOUVERS

APPEAR TO BE FUNCTIONAL

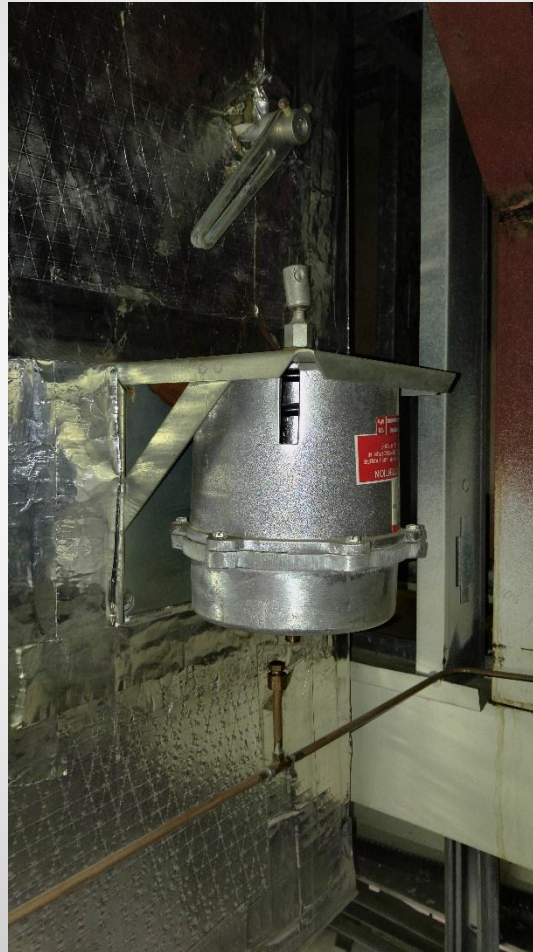
# DISCHARGE AIR DAMPER MOTOR

NOT CONNECTED BECAUSE THERE IS NO LOUVERS

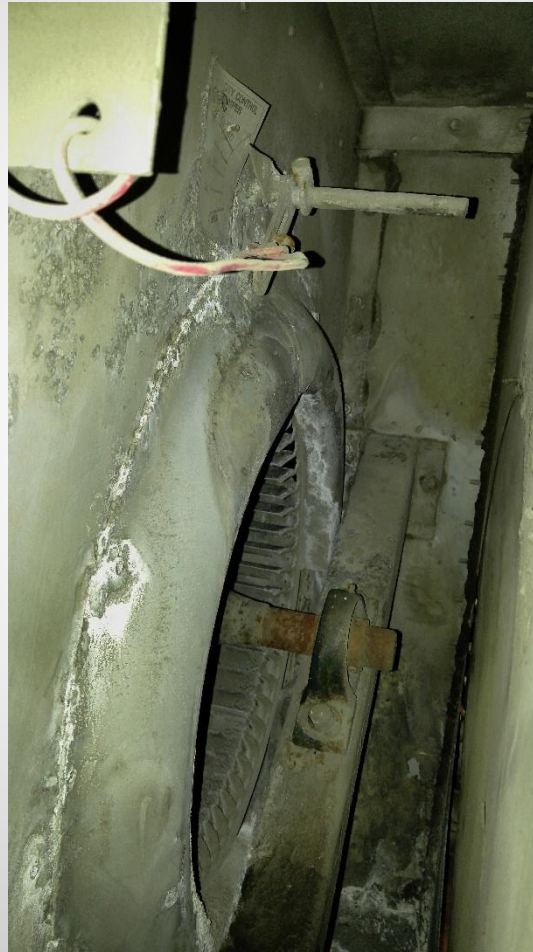
# CAPACITY CONTROL DAMPER

SHOULD BE REMOVED; NO LONGER NEEDED

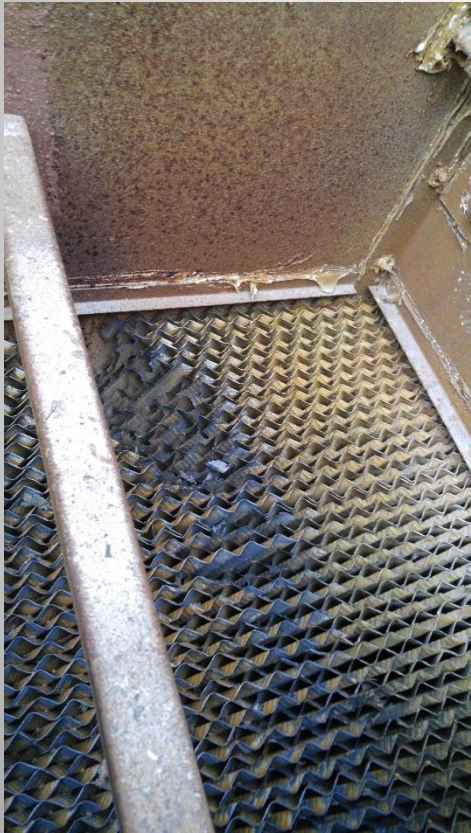
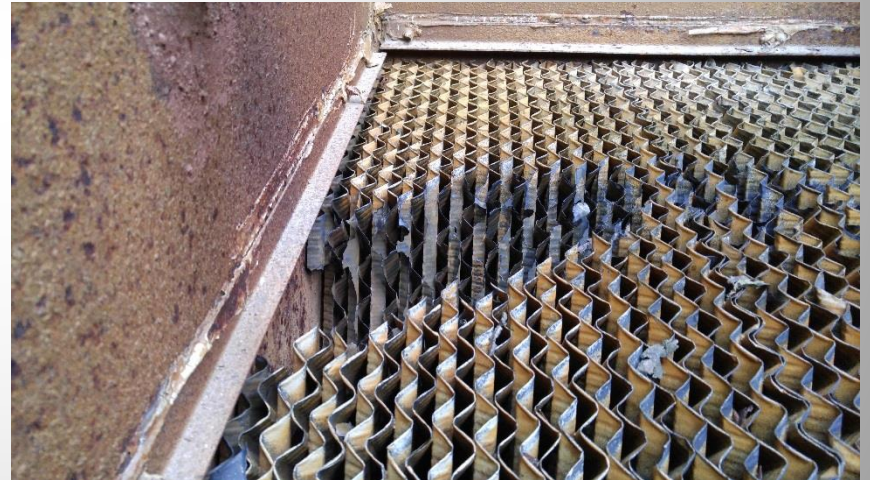
# FILL

## DAMAGED AND DIRTY

- Fill in Cooling Tower 1 is in poor condition and breaking apart. The fill is extremely dirty and very brittle.
- Fill in Cooling Tower 2 was not accessible from above. However, from the bottom, the fill appears quite dirty and is also very brittle.
- Fill in both cooling towers will need to be replaced.

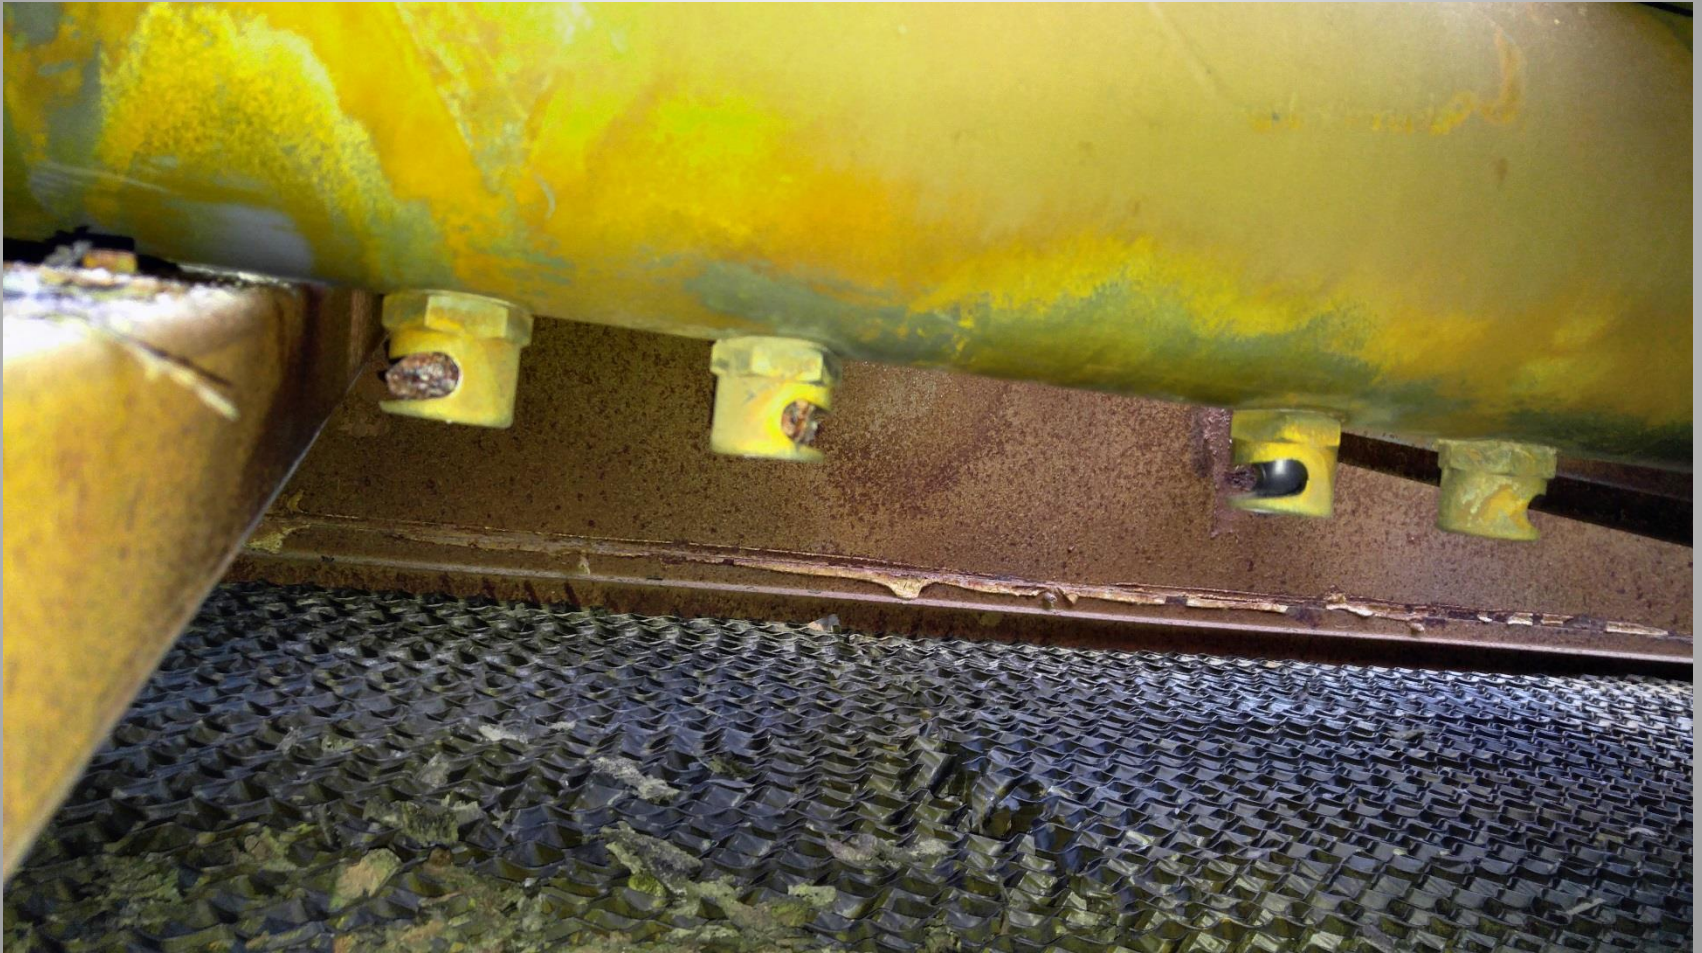
# DAMAGED FILL AND PLUGGED NOZZLES

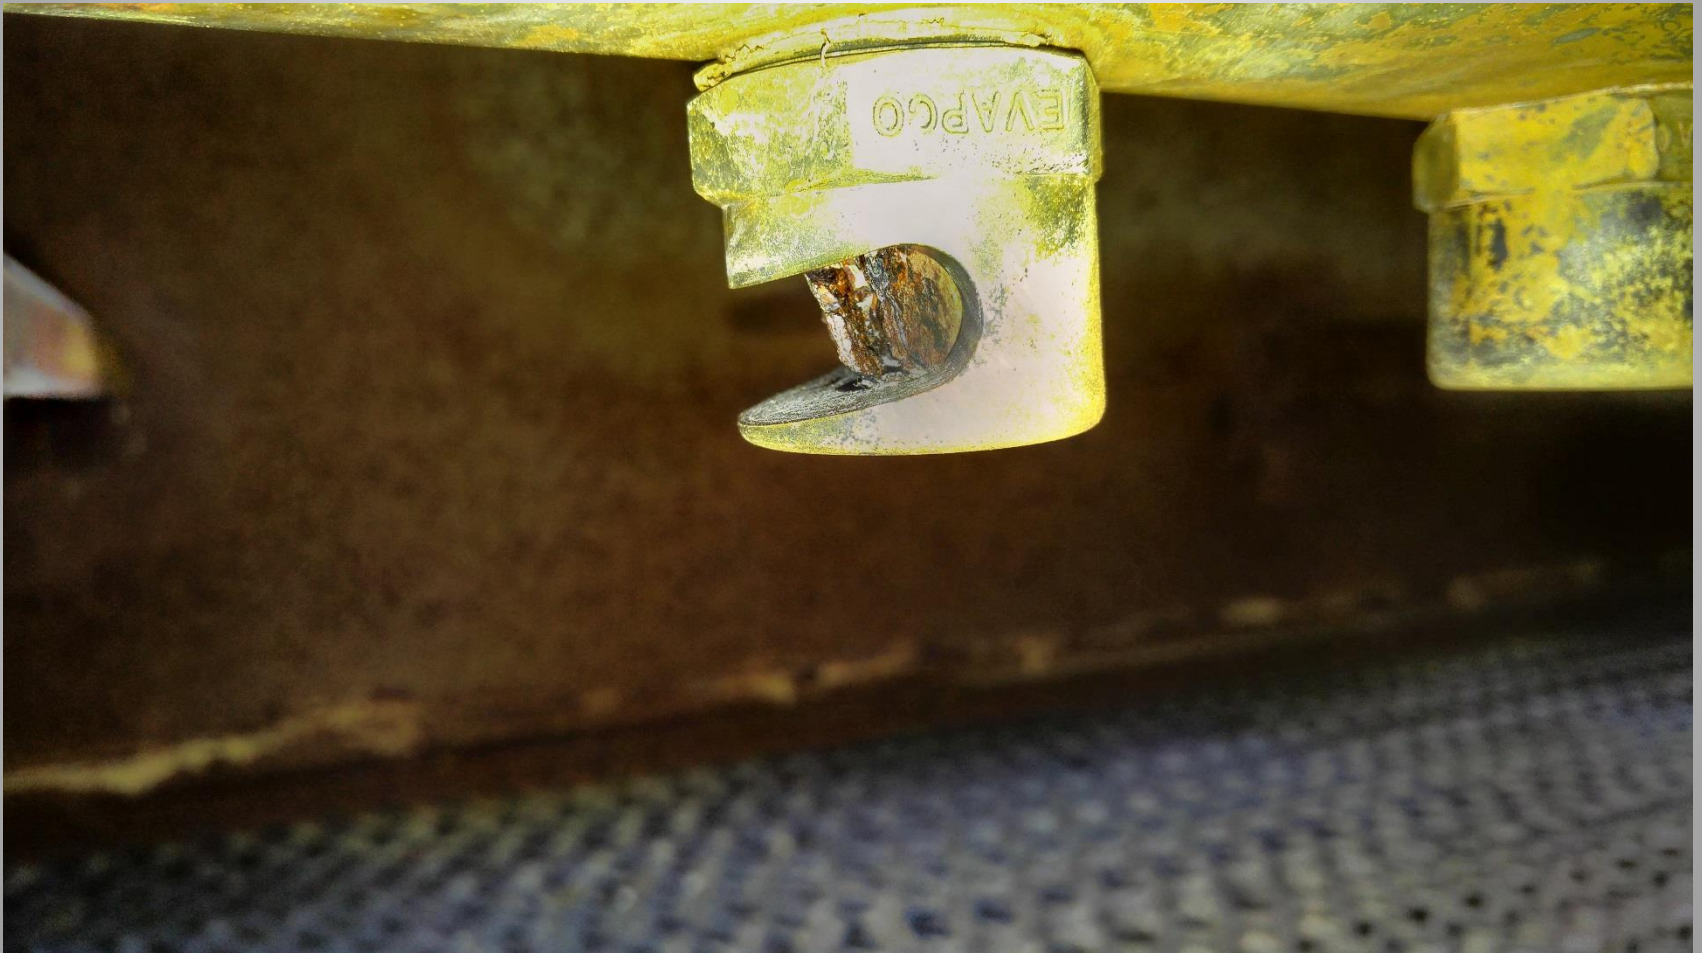
# NOZZLES

NOZZLES ARE PLUGGED

- Headers are plugged solid; many nozzles plugged and damaging the fill.
- The spray pattern is poor and ineffective.
- The header section needs to be removed and cleaned or replaced. Nozzles should be replaced.

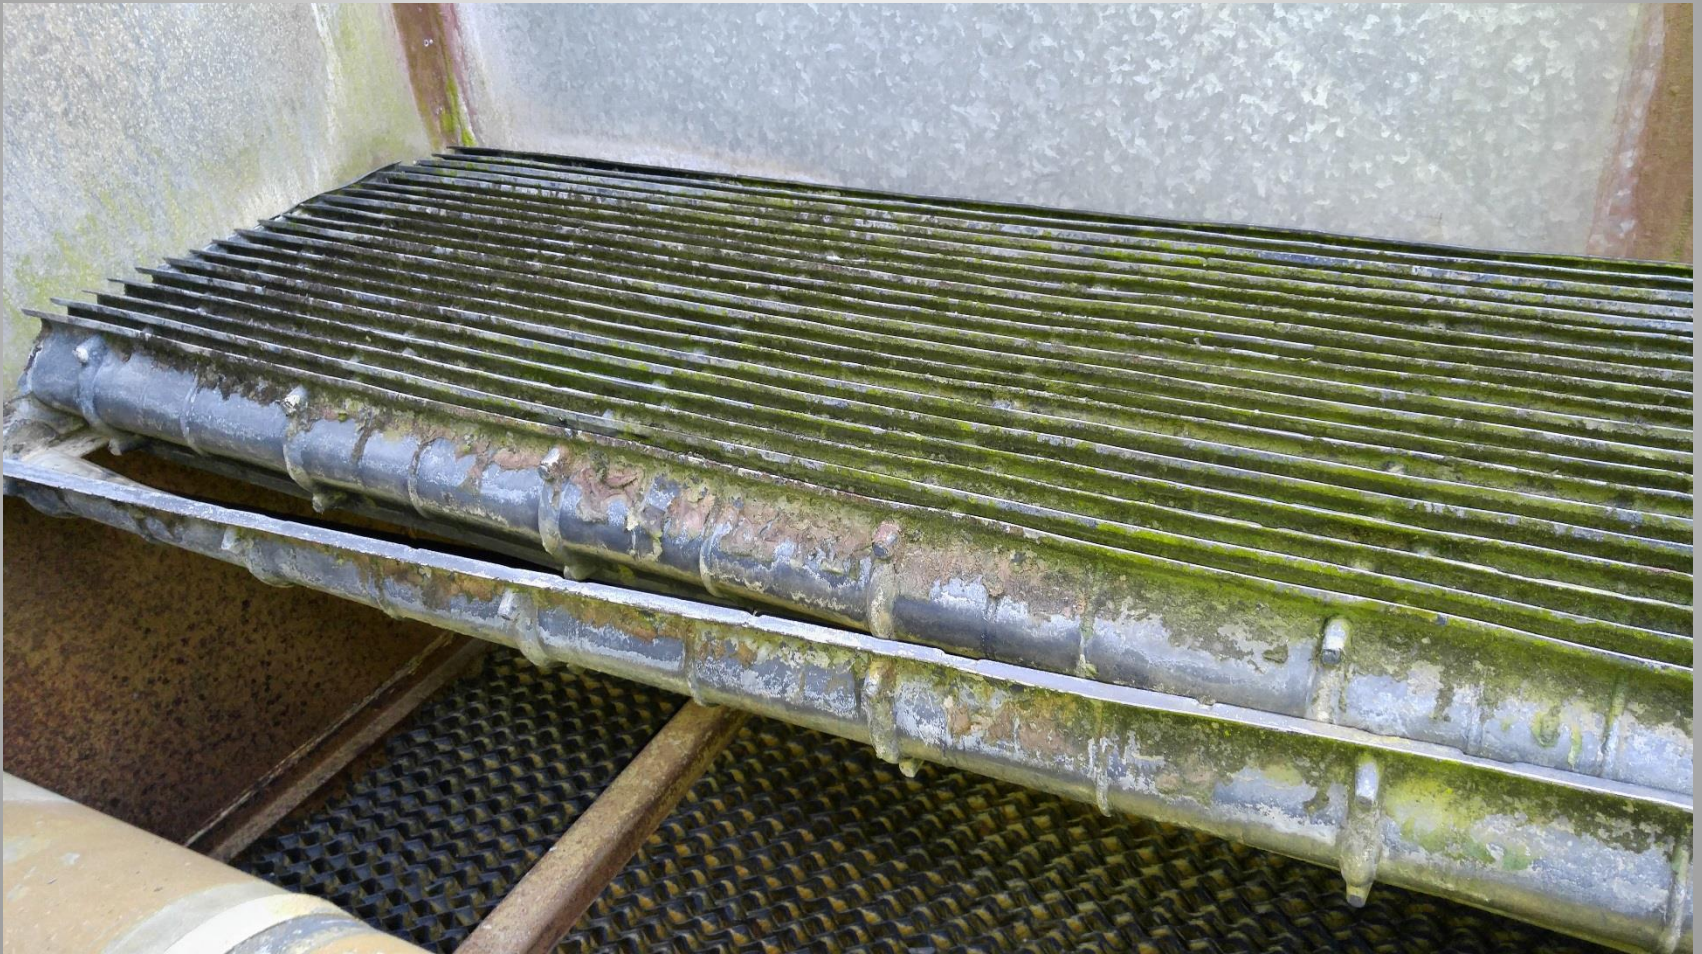
# ELIMINATORS

BROKEN & ALGAE GROWTH

- The eliminators are plugged and covered with debris.
- Very brittle and falling apart.
- Algae and mold growth present.
- The eliminators are in poor condition.

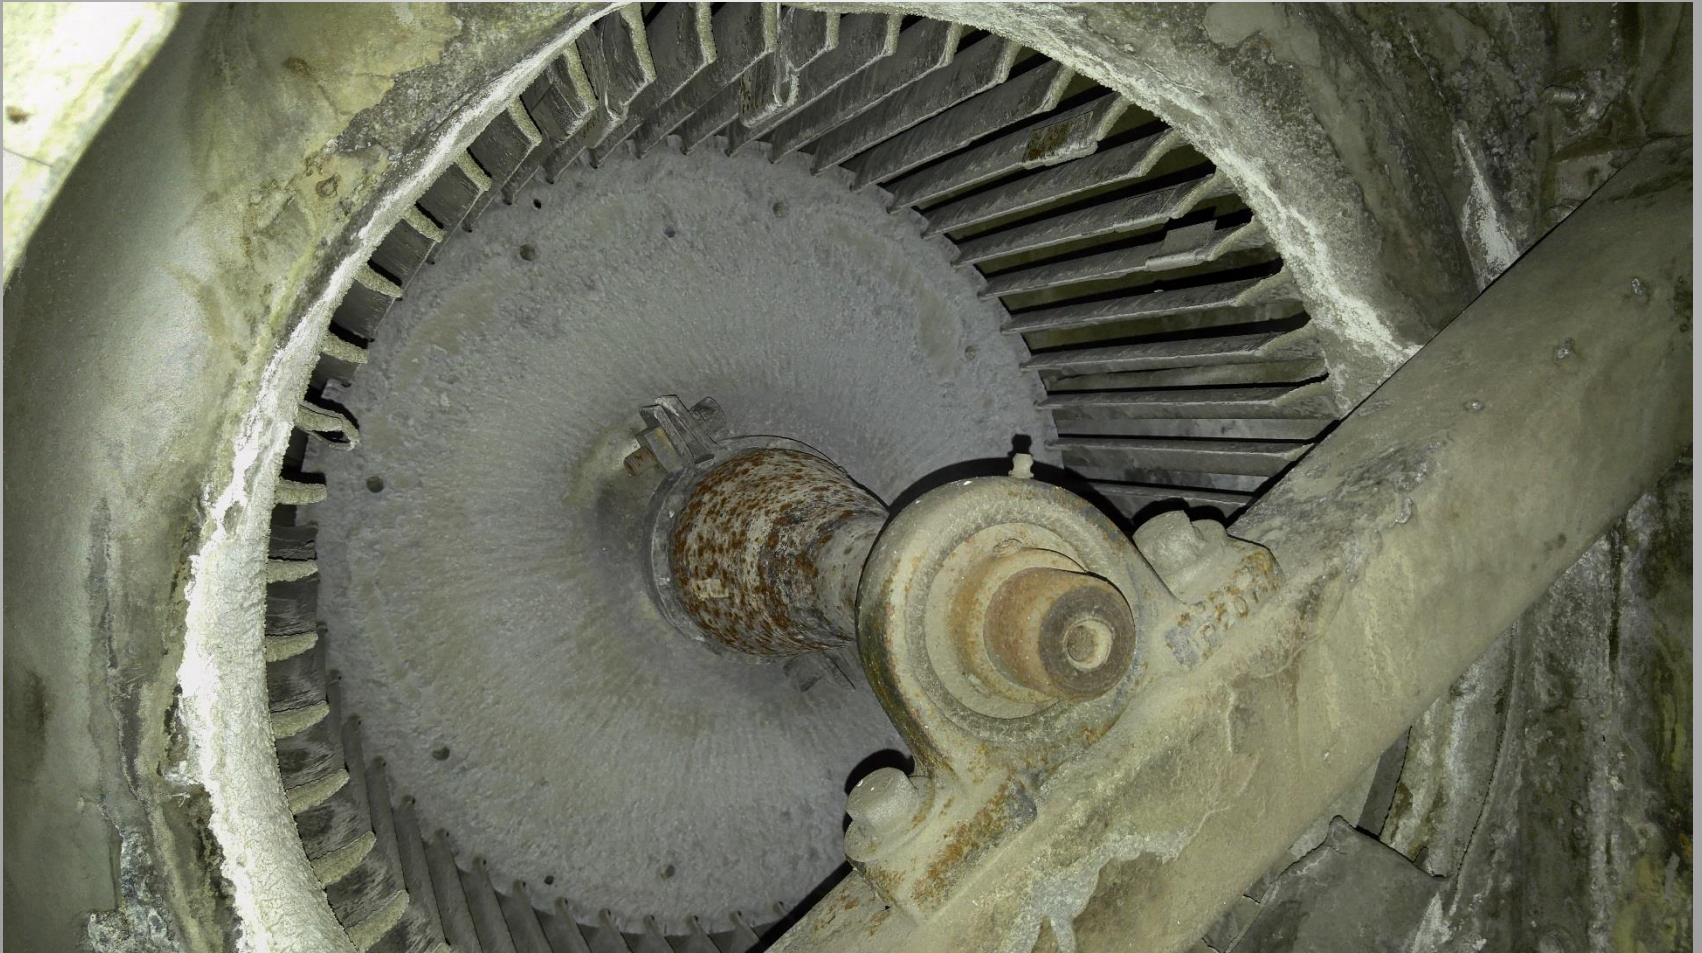
# BLOWER SECTION

## SCALE BUILD UP

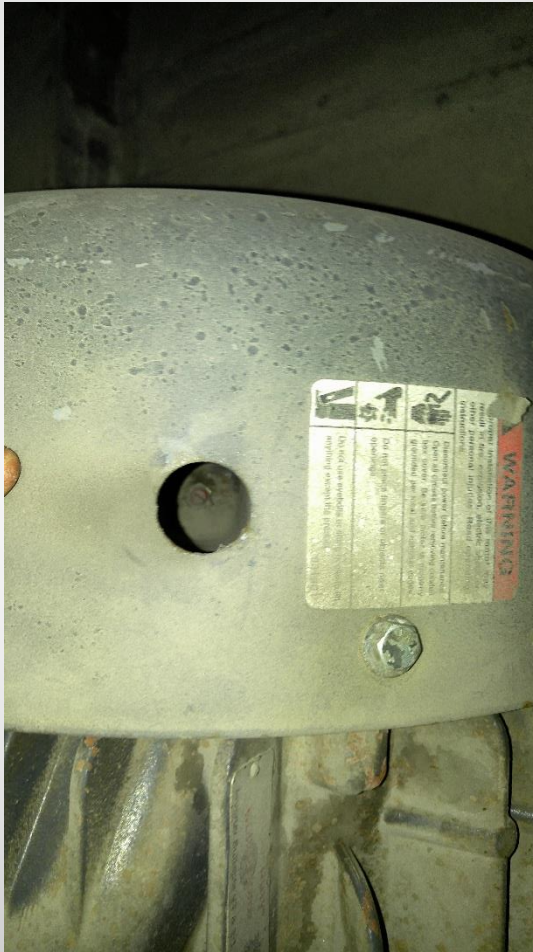
# MOTOR END BELL GREASE FITTING

DOES NOT APPEAR TO BE GREASED

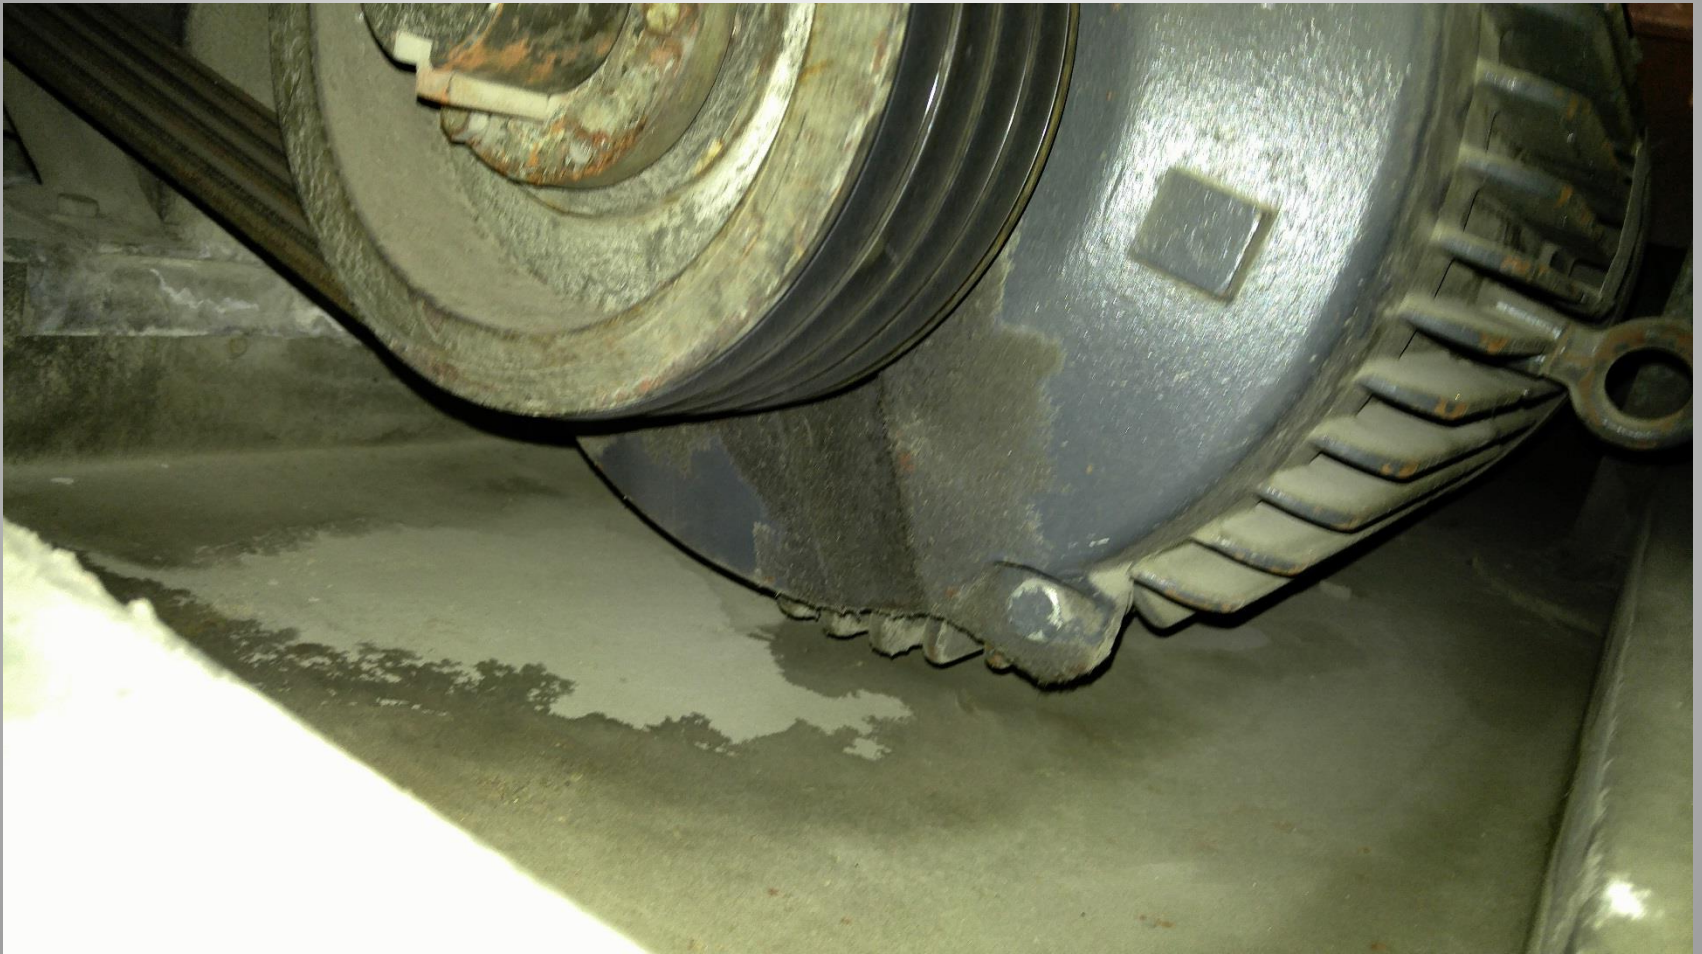
# OPPOSITE MOTOR END BELL

GREASE RUNNING DOWN MOTOR

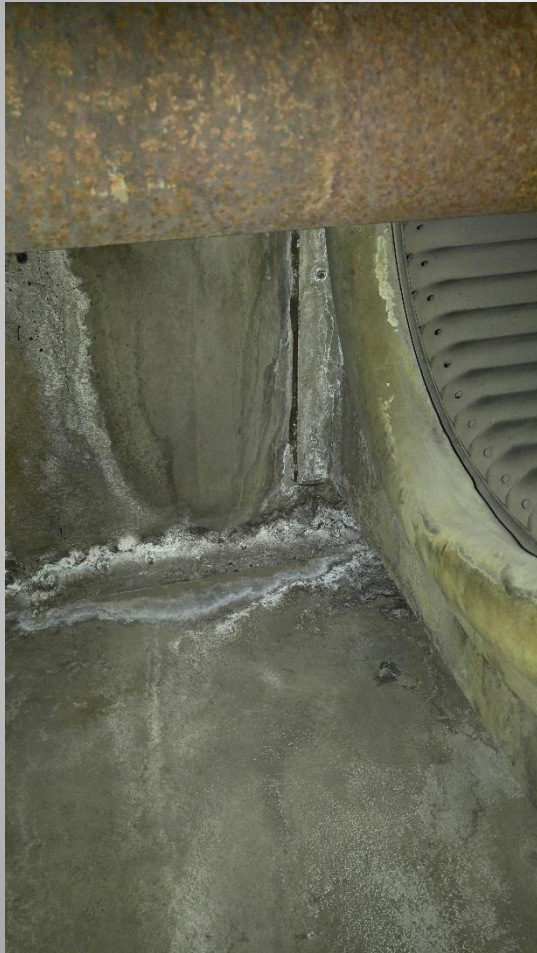
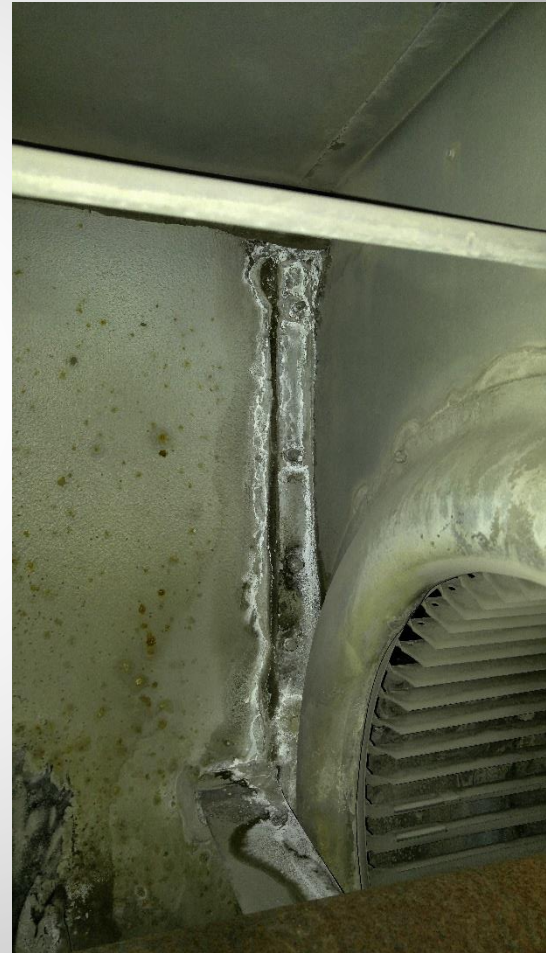
# BLOWER SECTION

## SIGNS OF LEAKAGE

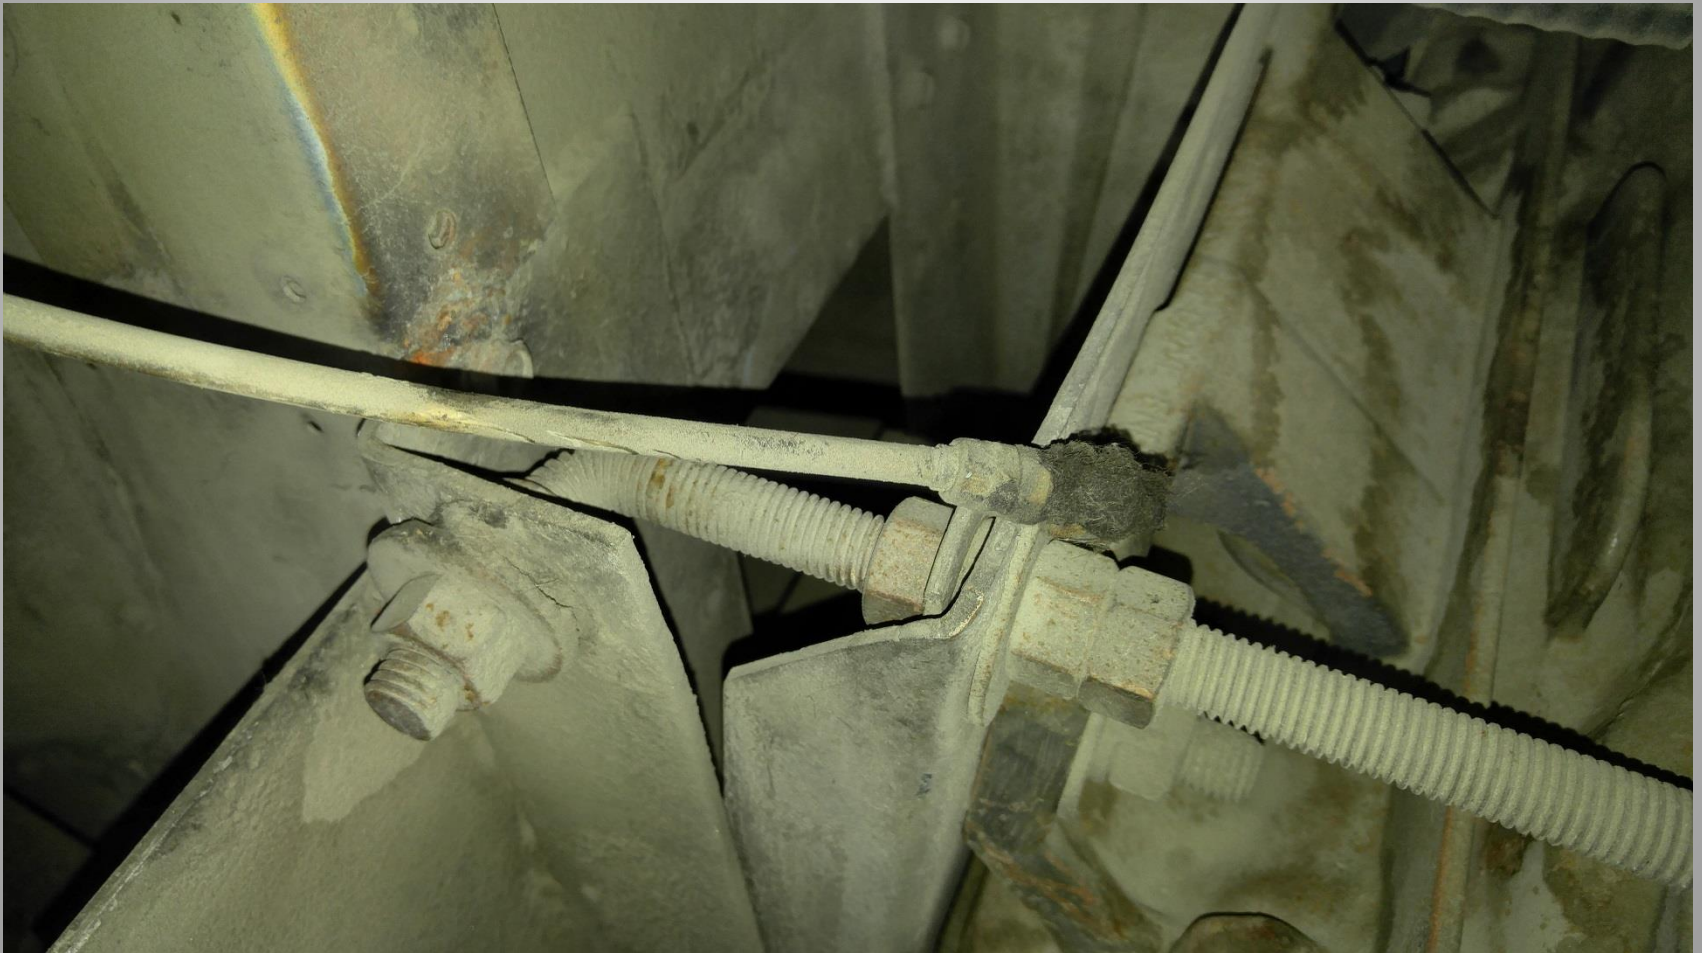
# GREASE LINE DISCONNECTED

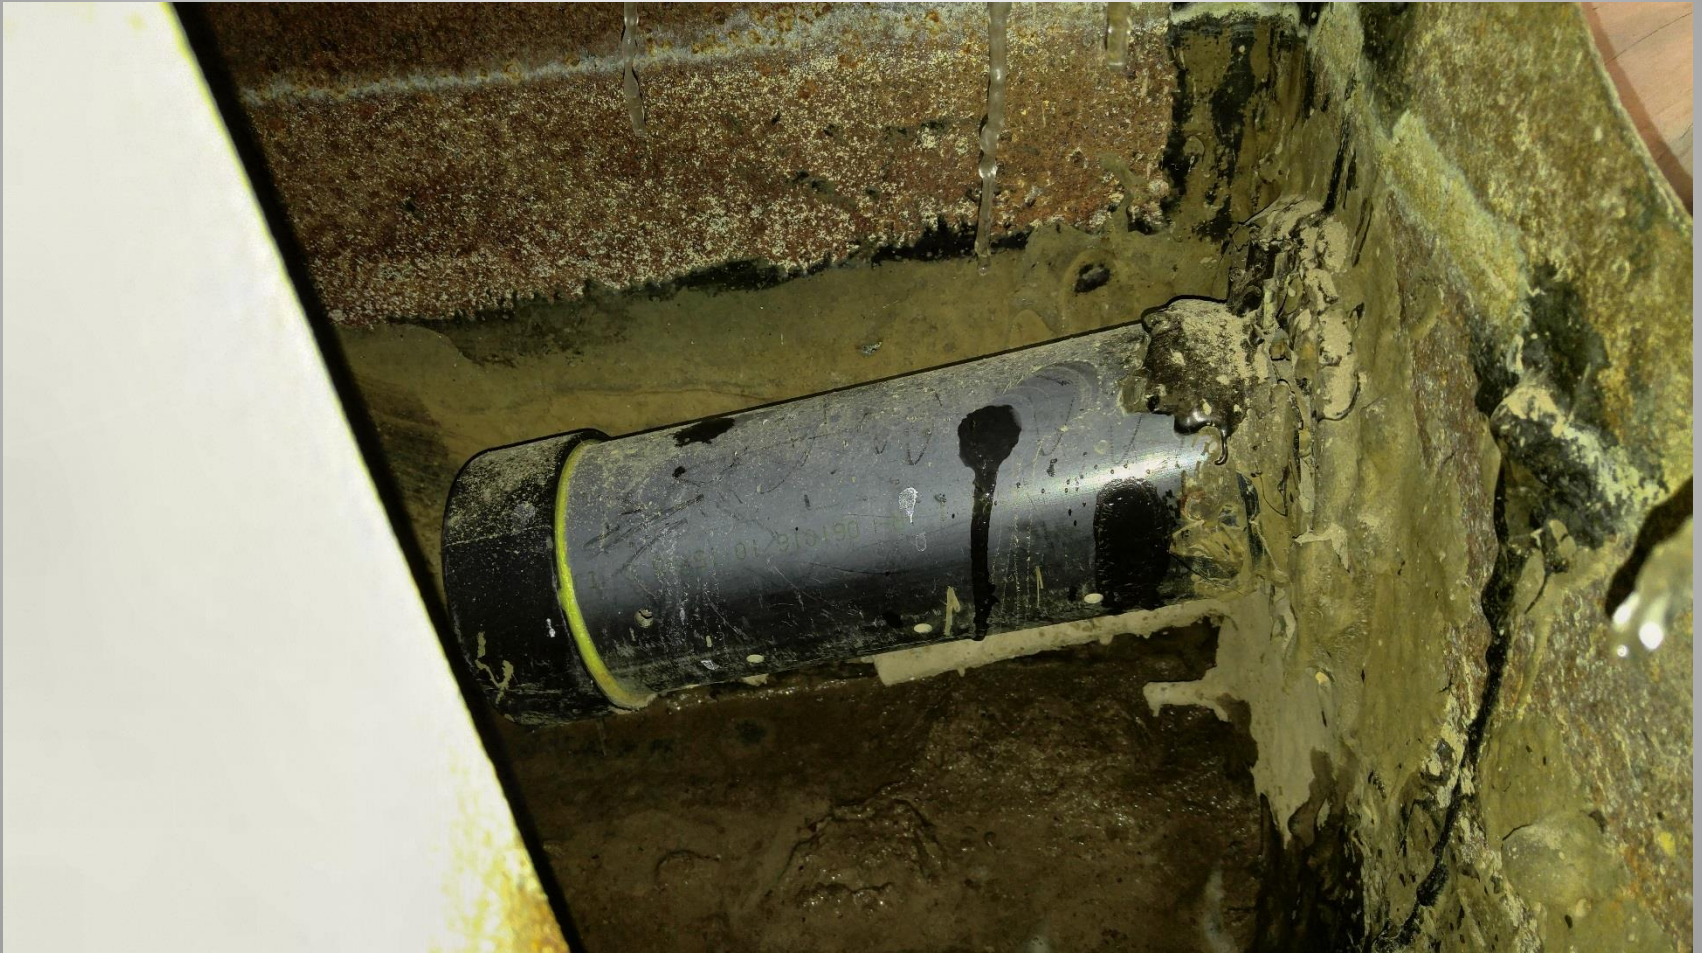
# ELECTRONIC WATER LEVEL CONTROL

BROKEN OFF OF SIDE OF TOWER; NO ACCESS TO CLEAN

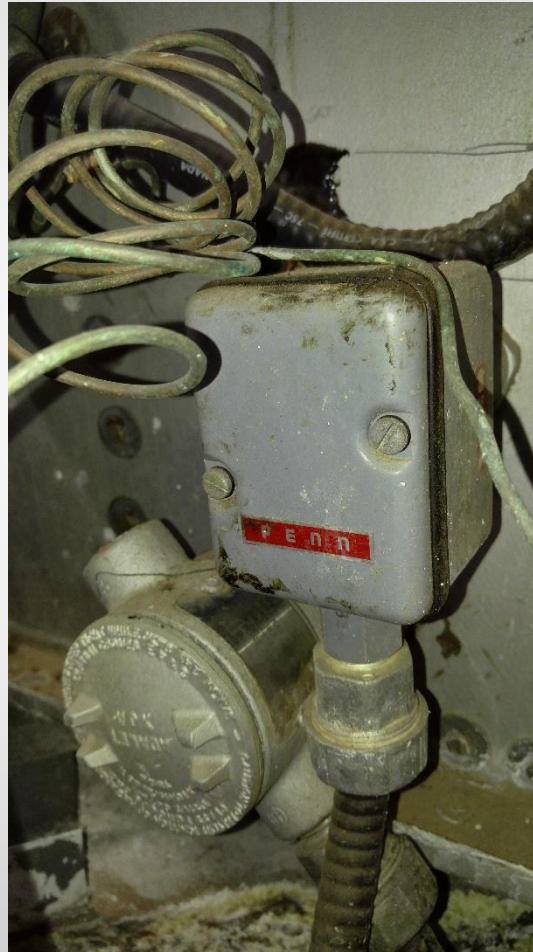
# SUMP HEATER CONTROL

SUMP HEATER NOT FUNCTIONAL

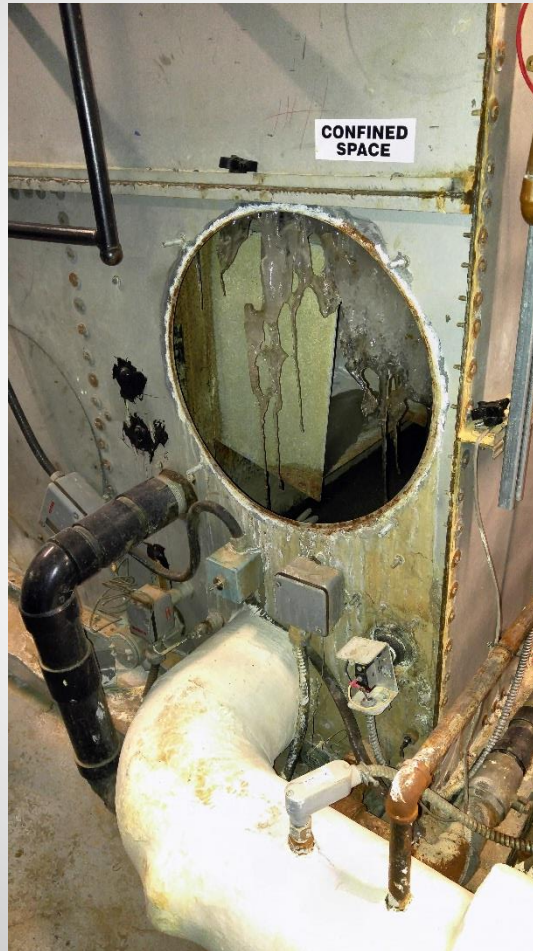
# ACCESS DOOR

ICE BUILD UP

SUMP HEATER NOT FUNCTIONAL; EWLC OUTSIDE COVER IS BROKEN

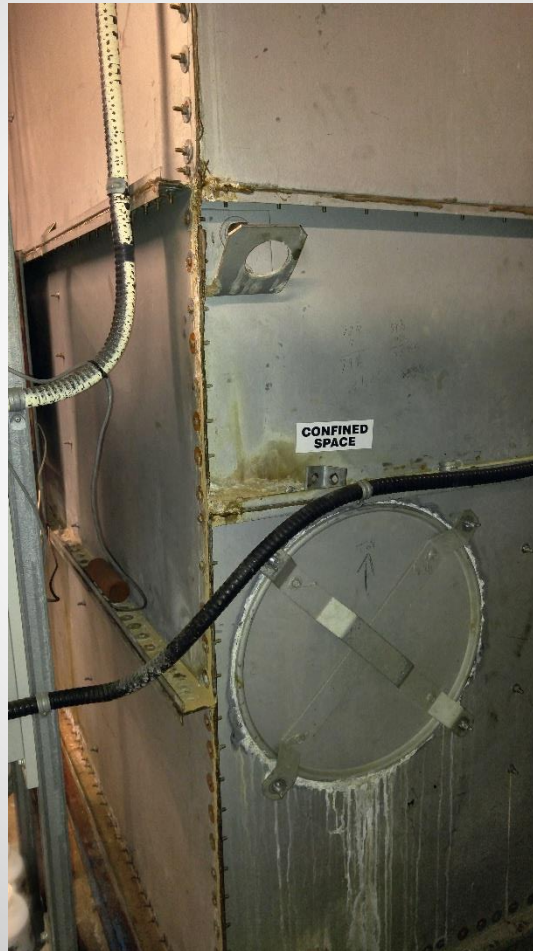
# ACCESS DOOR

## SIGNS OF LEAKAGE

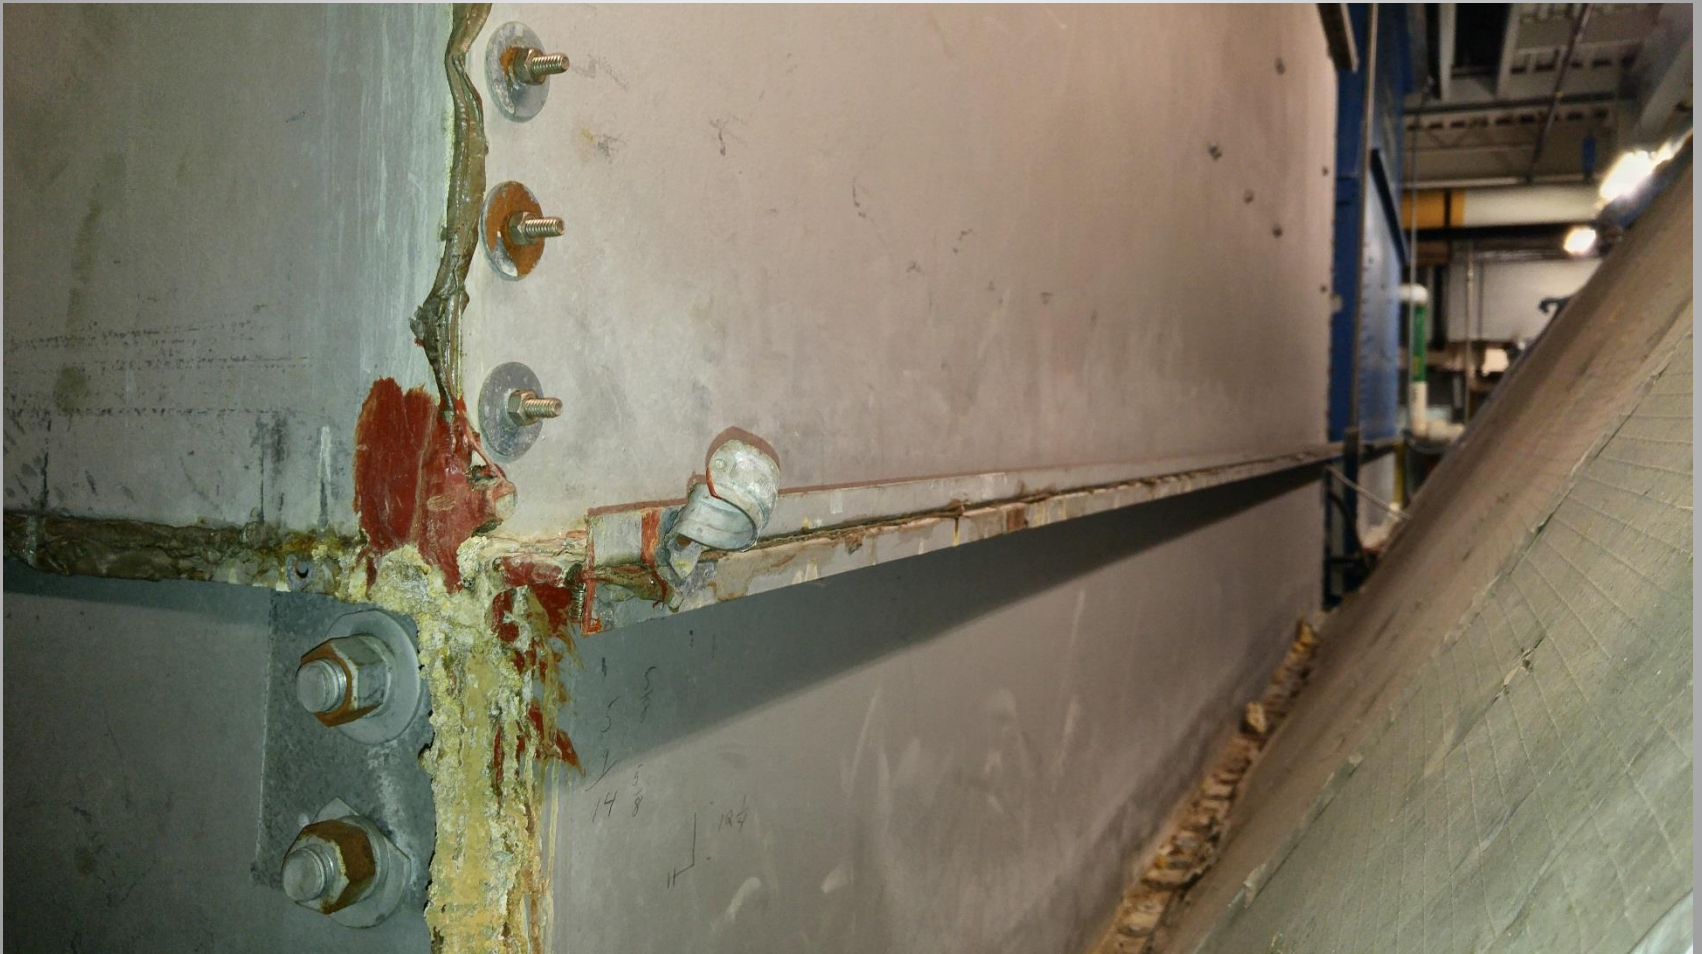
# SEAMS

NEED TO CONFIRM IF LEAKING CURRENTLY

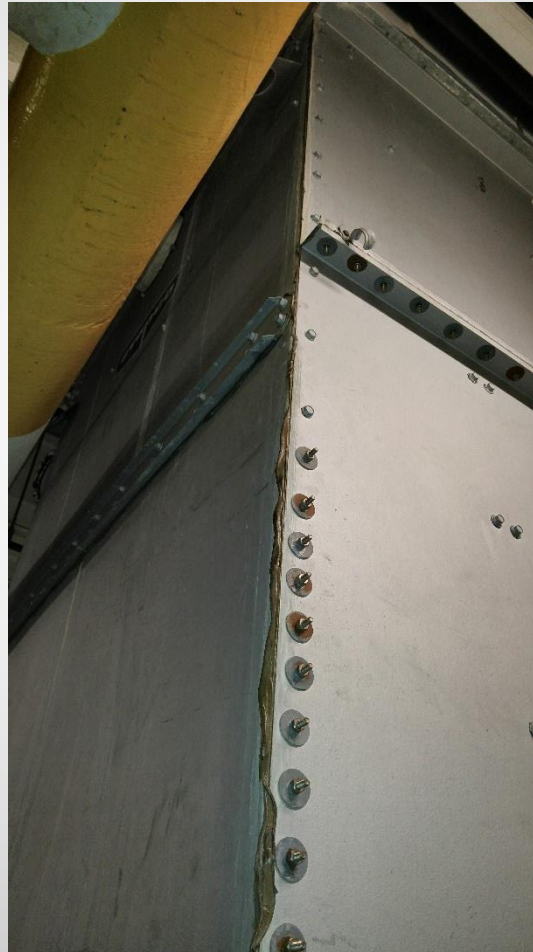
# SEAMS

APPEARS TO HAVE BEEN SEALED – NEED TO CONFIRM IF CURRENTLY LEAKING

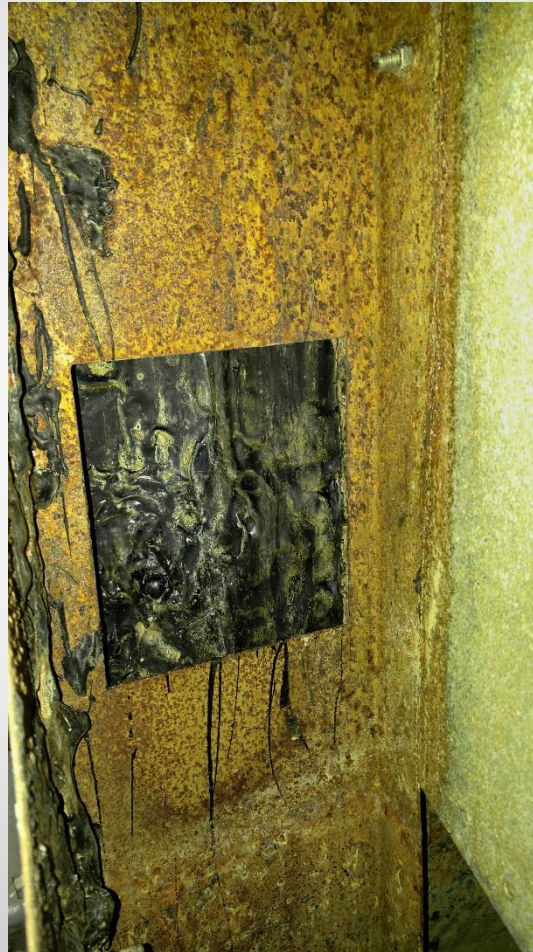
# PATCH

NOTE CORROSION
