# TOWER ASSESSMENT REPORT

PREPARED BY: MAC-TOWER INC  
15-1201 GRASSMERE RD  
WEST ST. PAUL, MANITOBA  
R4A 1C4

# **EVAPCO – COOLING TOWER 1**

## EVAPCO – COOLING TOWER 2

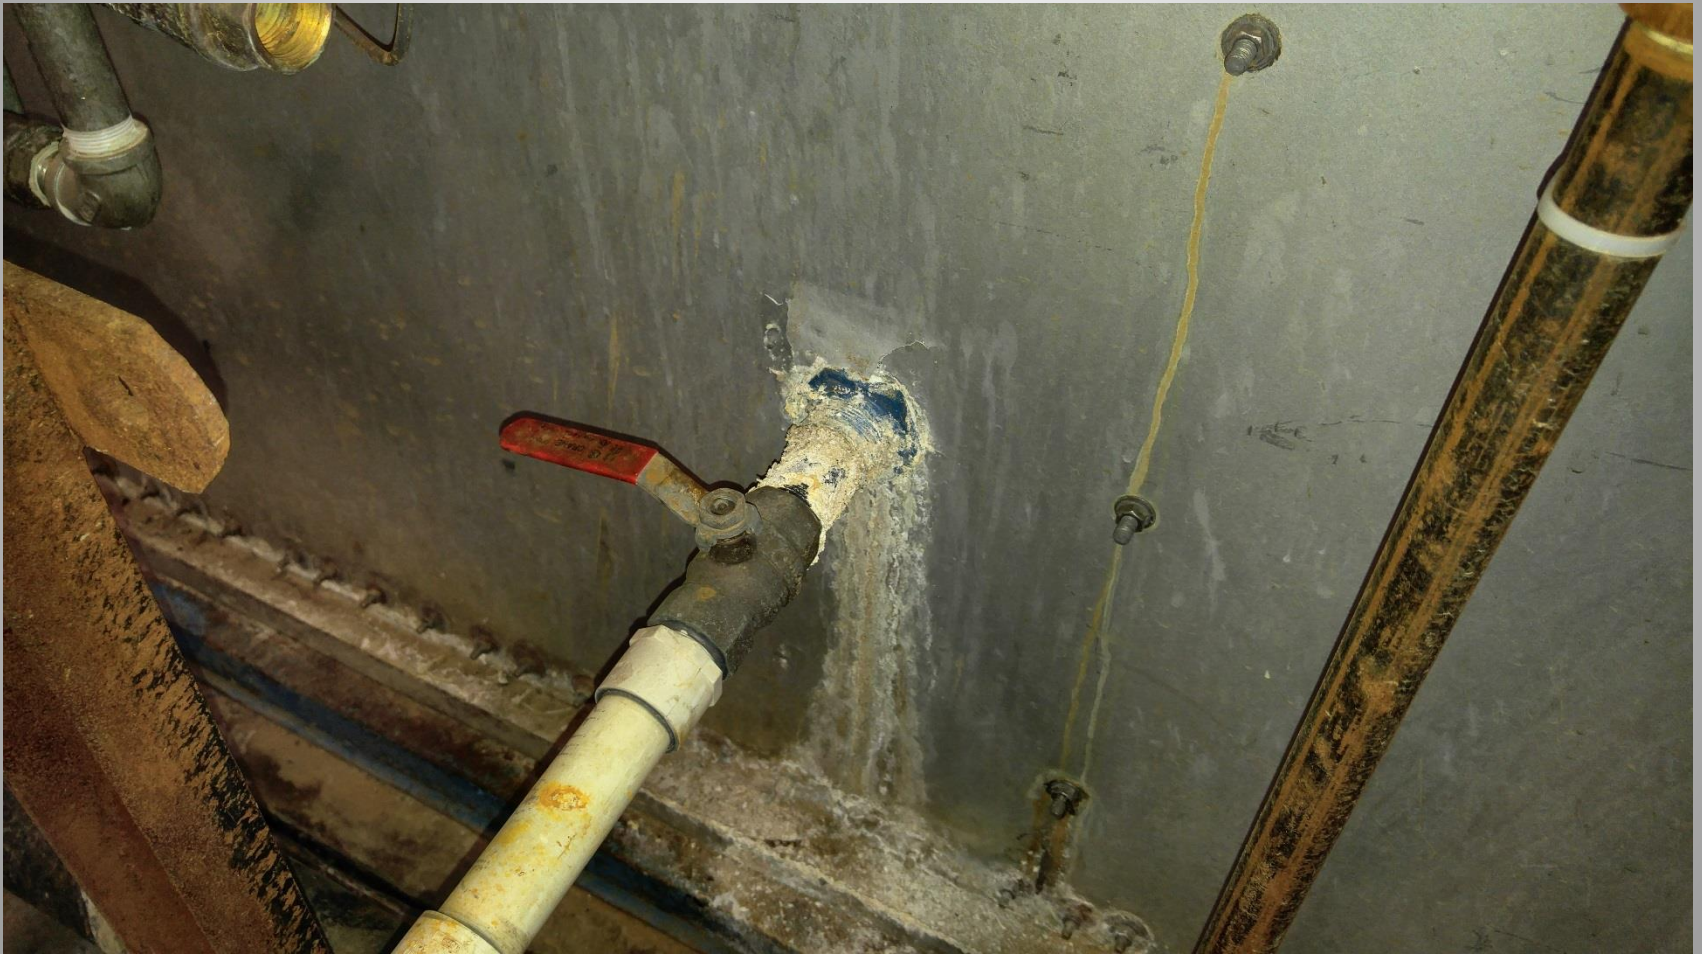
# LEAKING FITTING

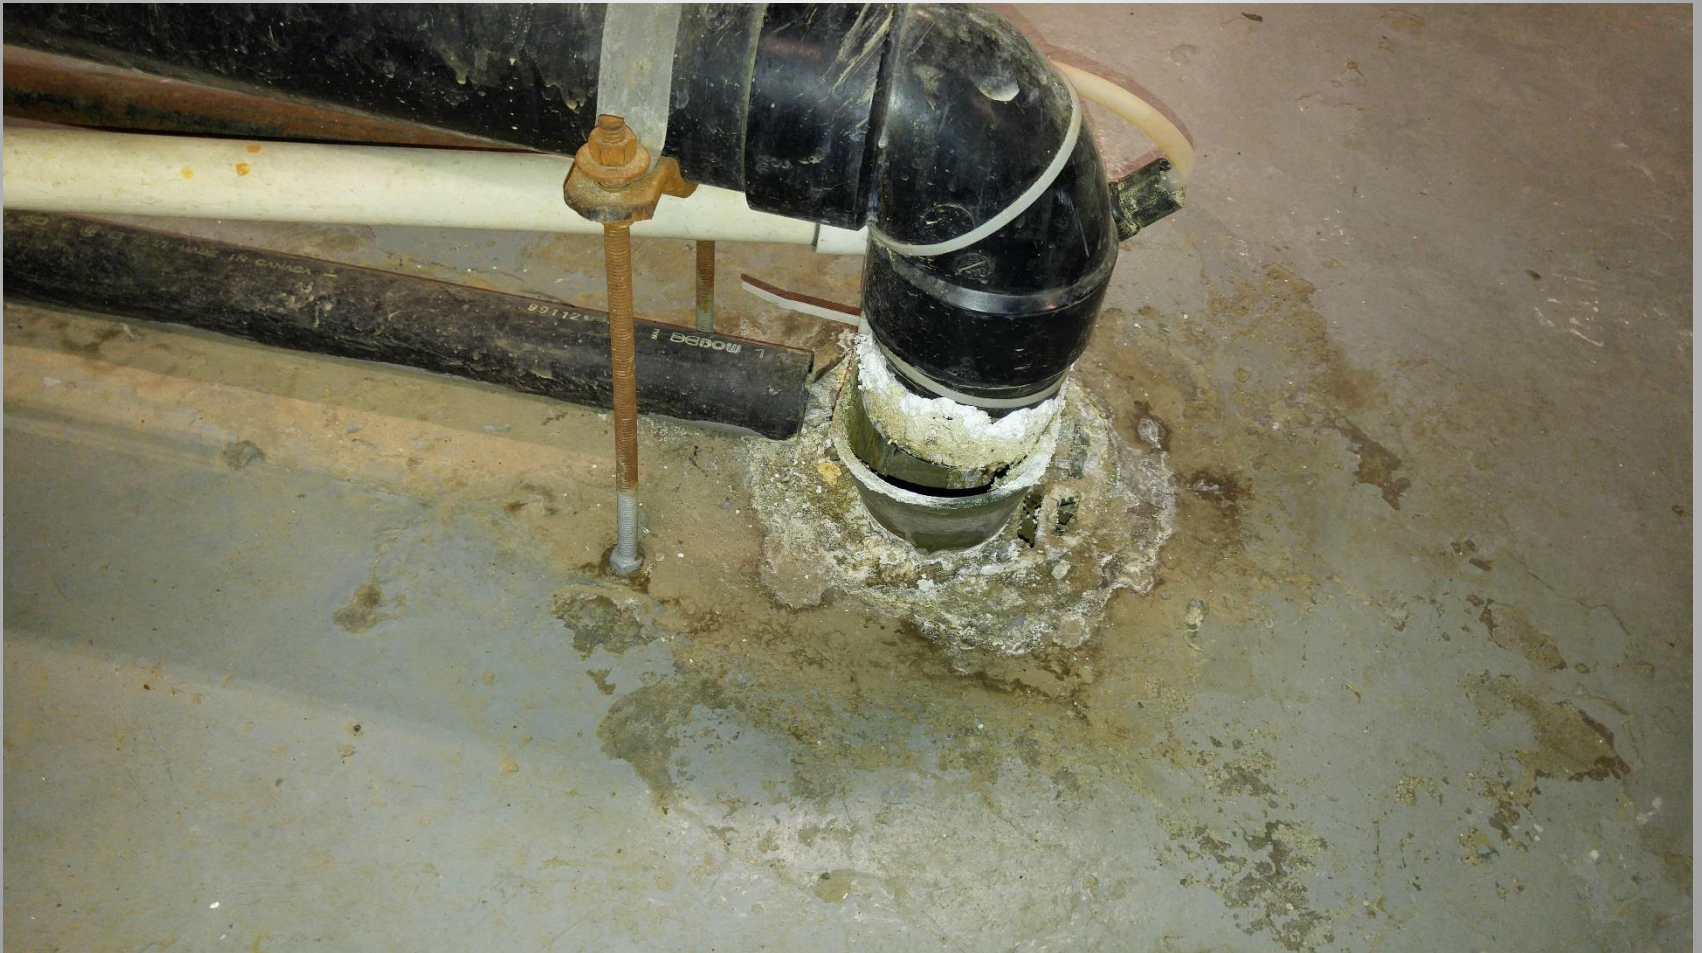
# DRAIN

CHEMICAL BUILD UP FROM BLEED OR OVERFILL

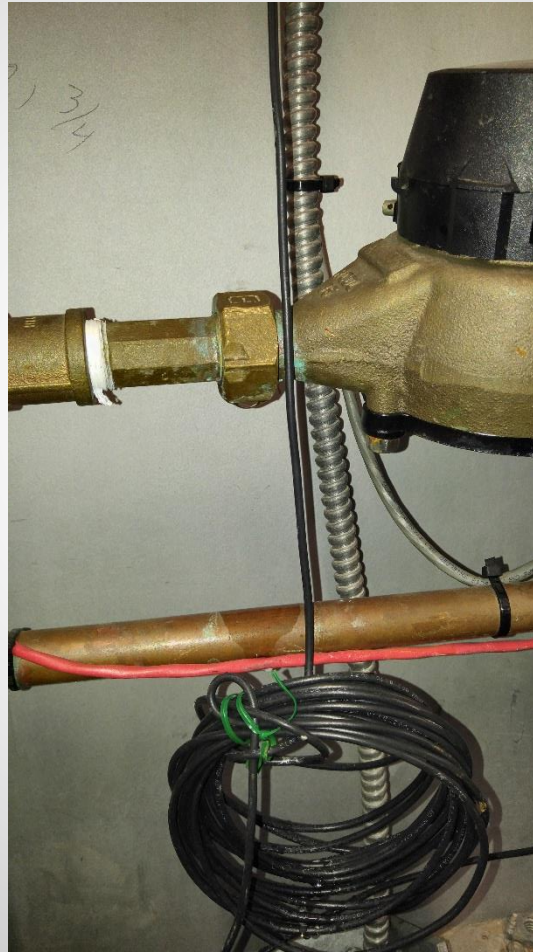
# WATER METER

WAS LEAKING – FIXED DURING INSPECTION

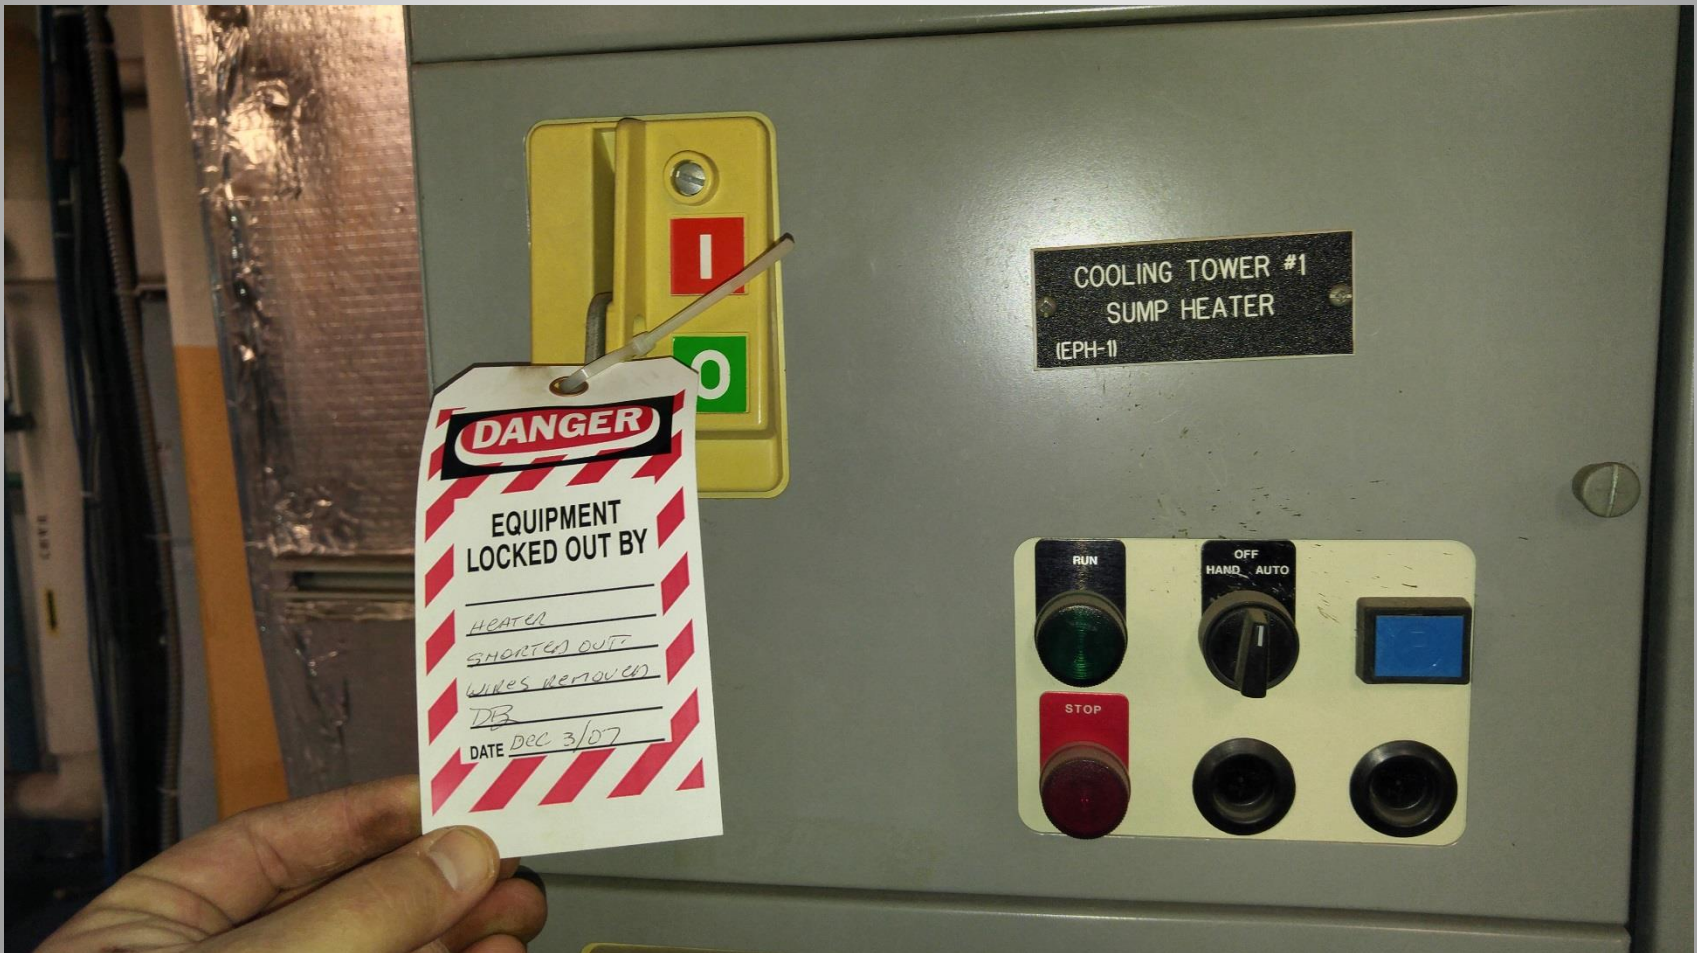
# SUMP HEATER

LOCKED OUT SINCE 2007

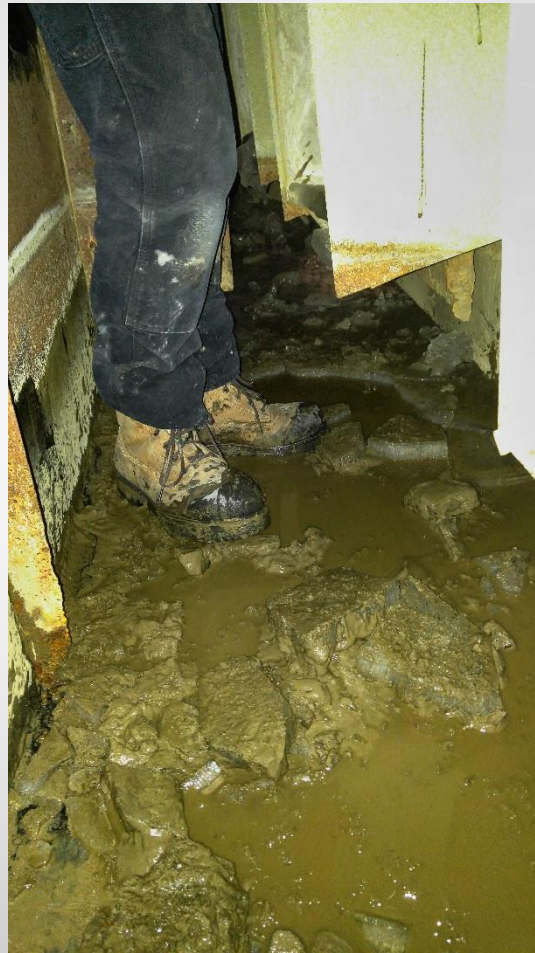
# SUMP

EXCESSIVE SEDIMENT AND DEBRIS IN SUMP

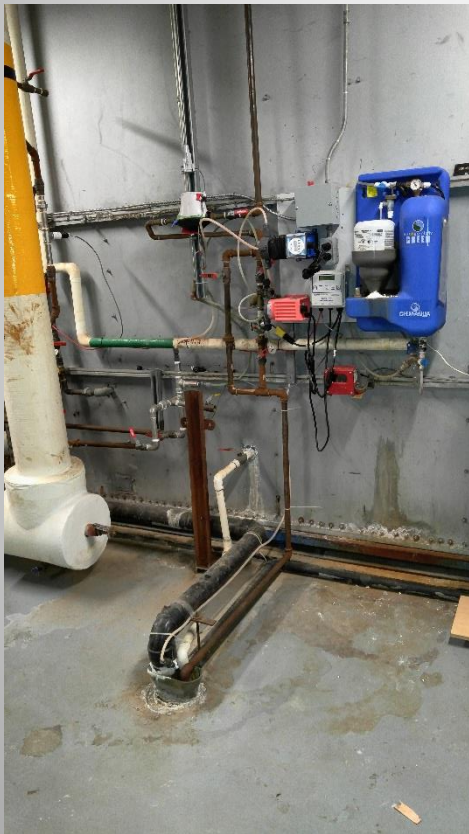
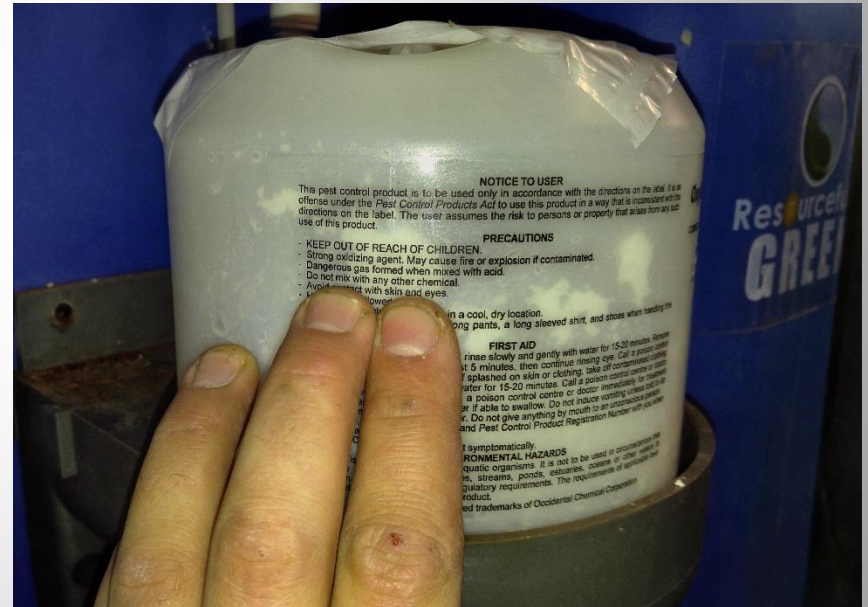
# CHEMICAL SET UP

**OXYCHEM: DANGEROUS GAS FORMED WHEN MIXED WITH ACID** (OTHER TOWER IS RUNNING ACID)

- Install new water treatment system that is safer and more effective.

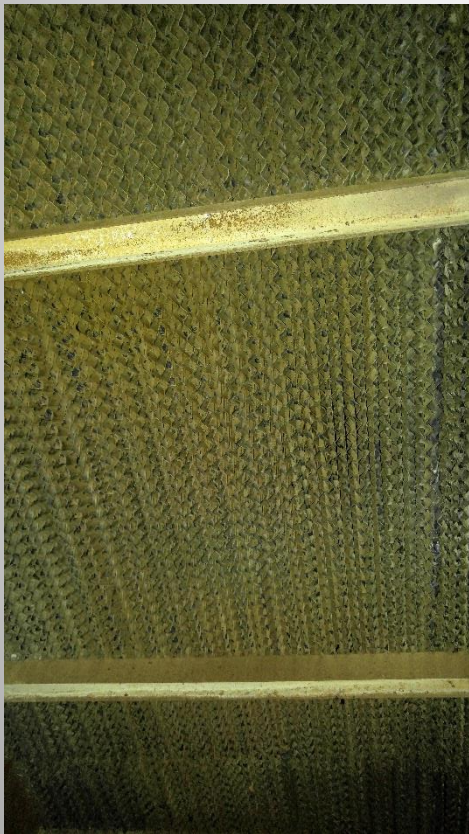
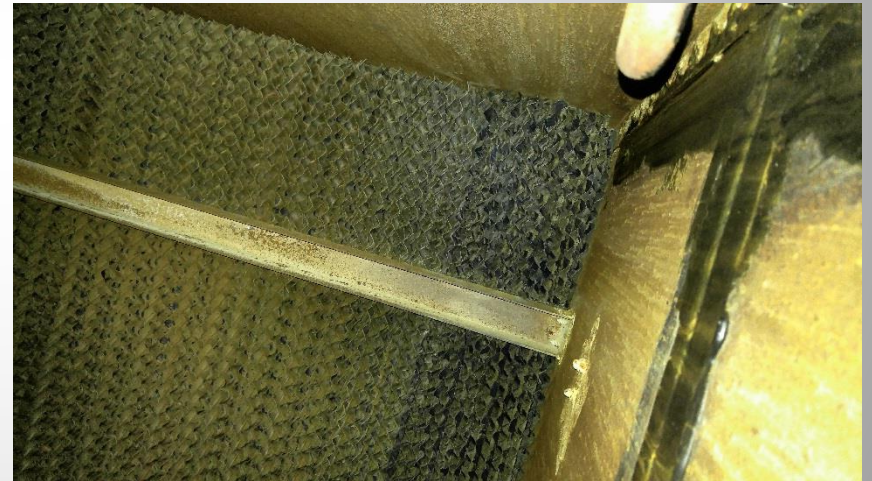
# FILL

DIRTY & BRITTLE

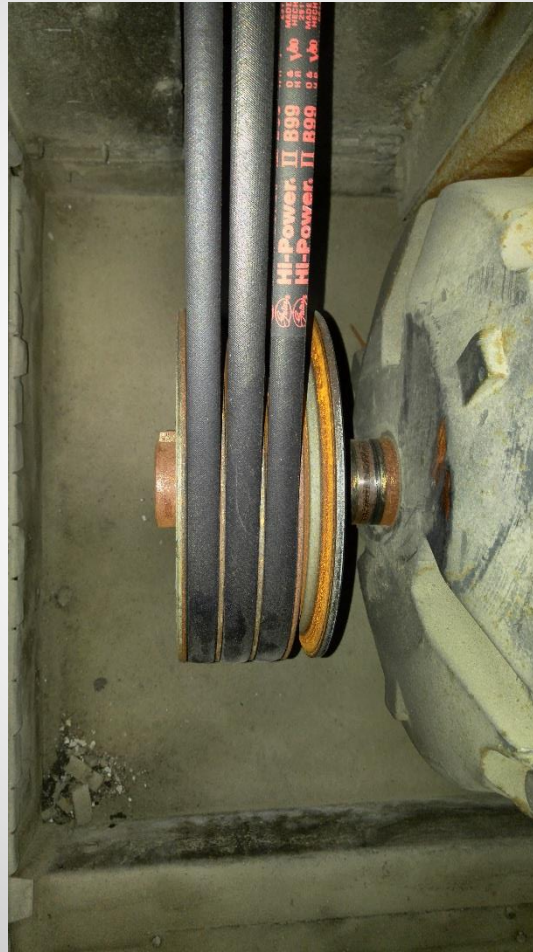
# BELTS

RECOMMEND USING 4 BANDED BELT  
1 BELT MISSING

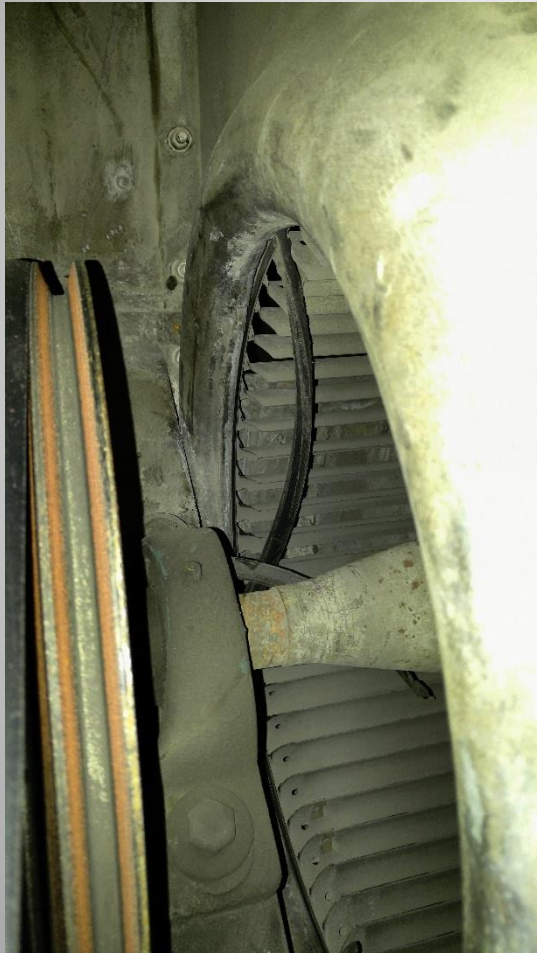
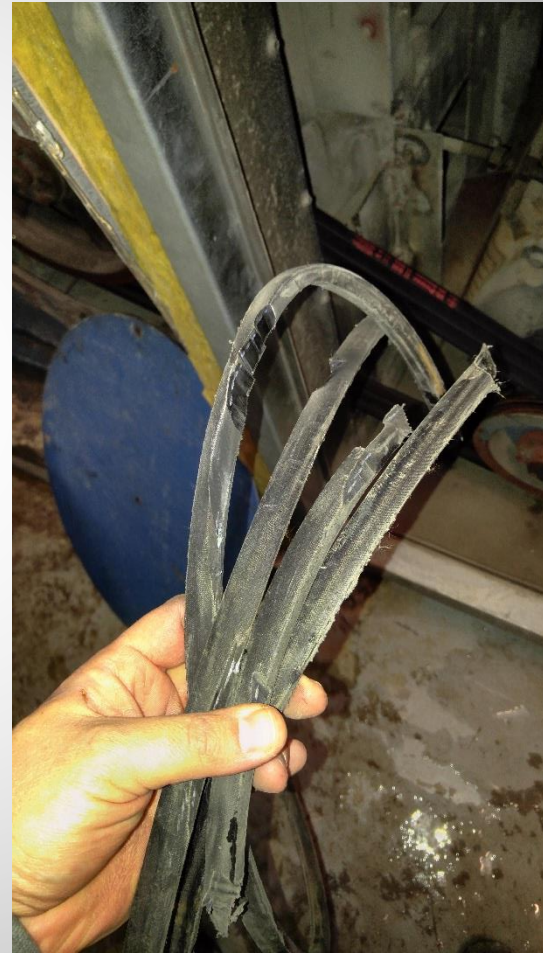
# BELTS

BELT STUCK IN MOTOR  
REMOVED BROKEN BELT DURING INSPECTION

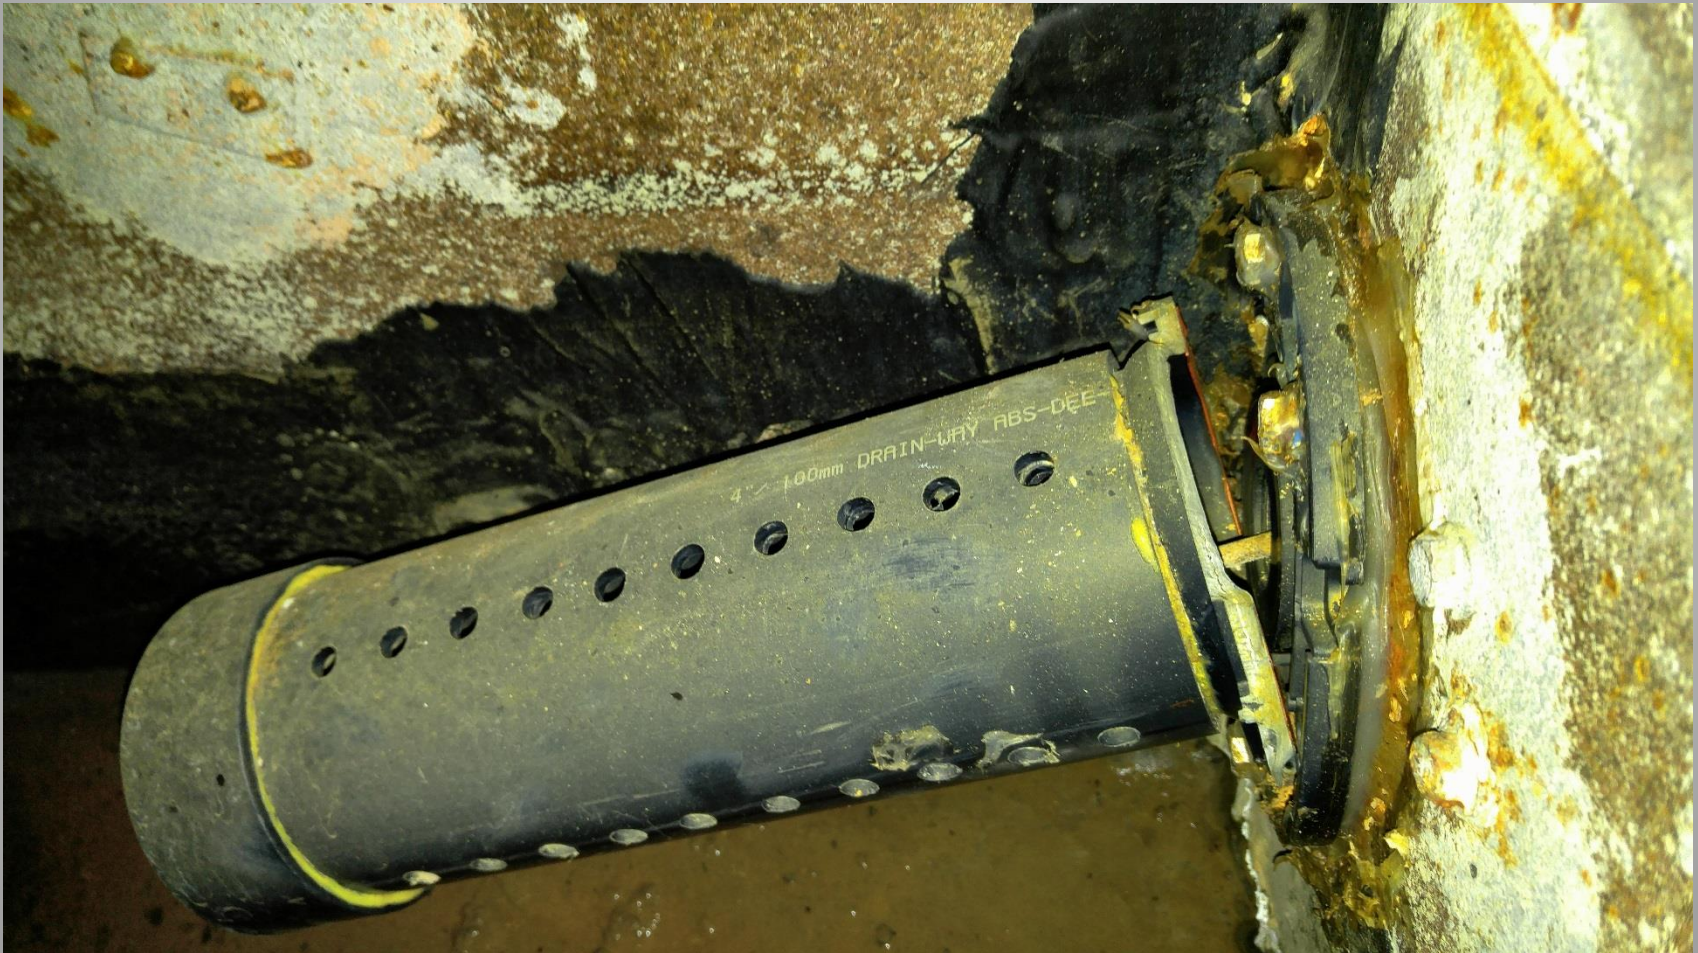
# ELECTRONIC WATER LEVEL CONTROL

BROKEN OFF OF SIDE OF TOWER; NO ACCESS TO CLEAN

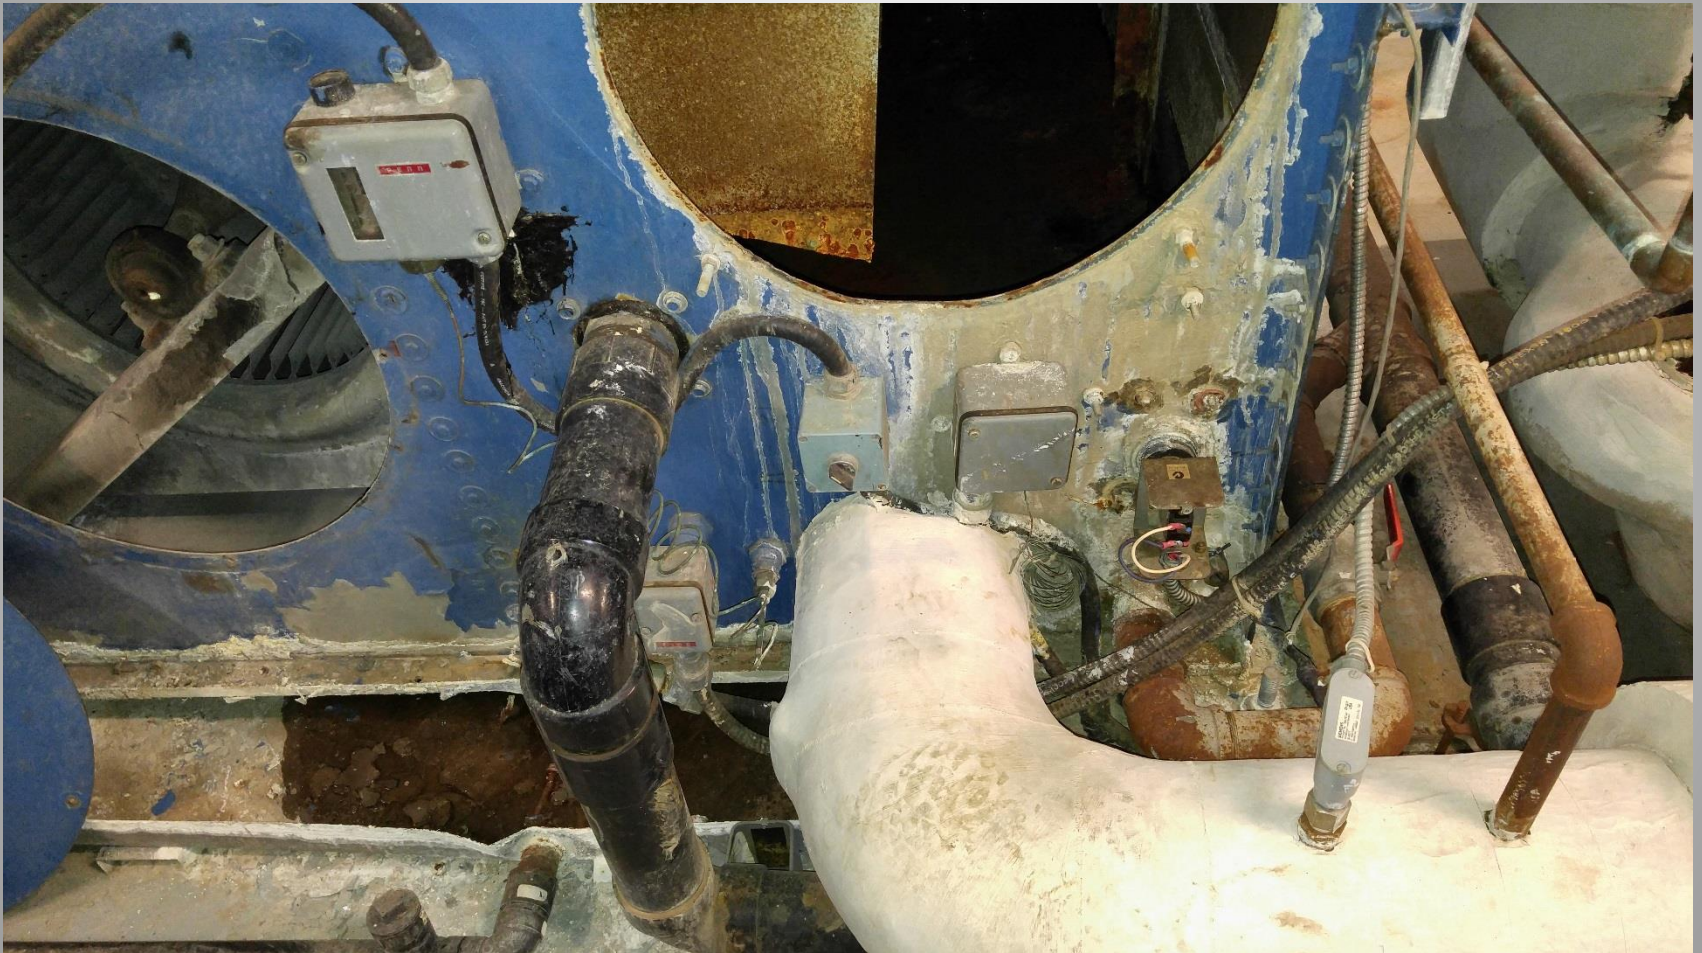
# ACCESS DOOR

## SIGNS OF LEAKAGE

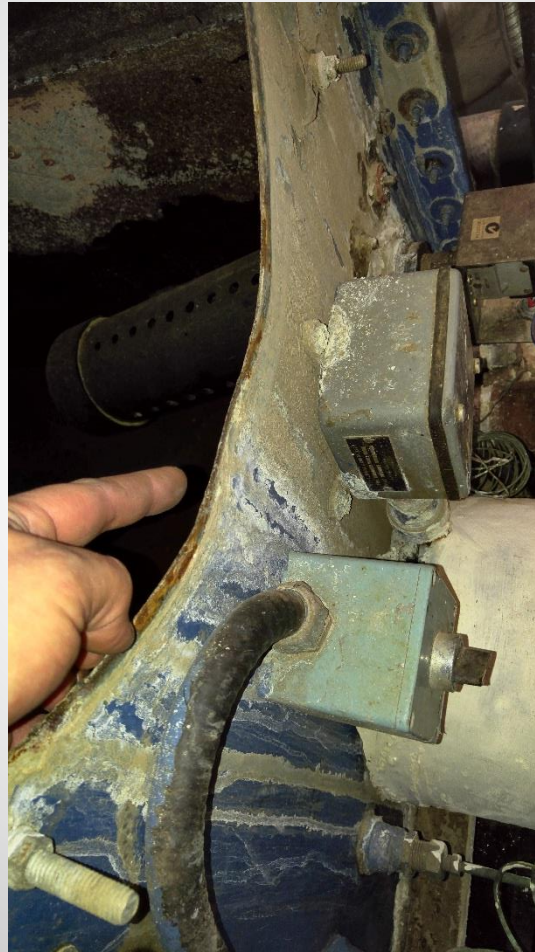
# ACCESS DOOR

PANEL BENT

- Corrosion and scale build up on panels and support braces.
- Bent panel near access door causing excess leakage.
- Overall structural integrity is fair to satisfactory.

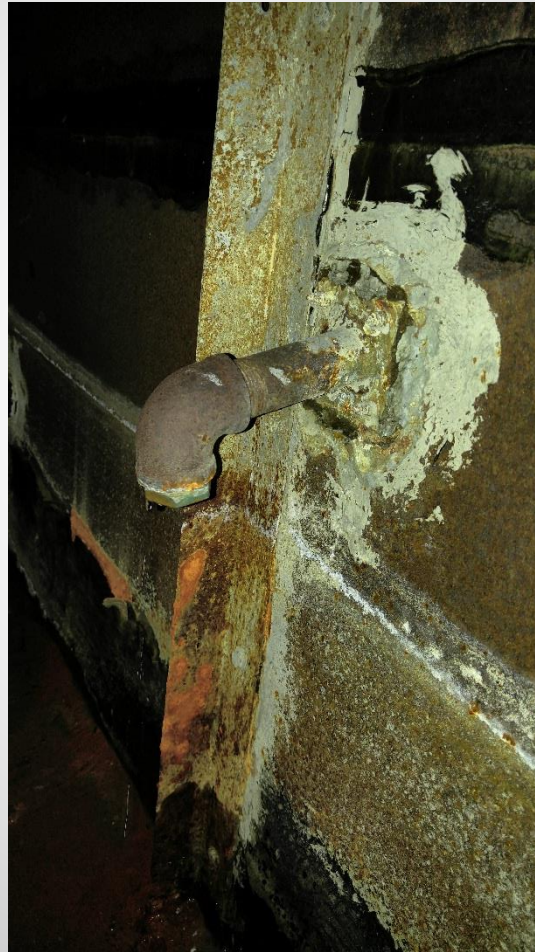
# WATER FILL VALVE LEAKING

ISOLATION VALVE LEAKS

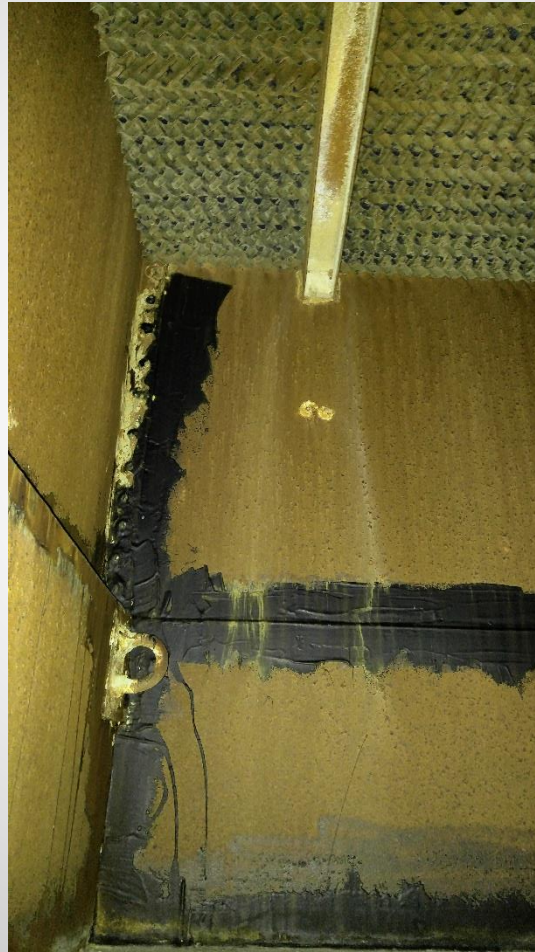
# SEAMS

NEED TO CONFIRM IF LEAKING CURRENTLY

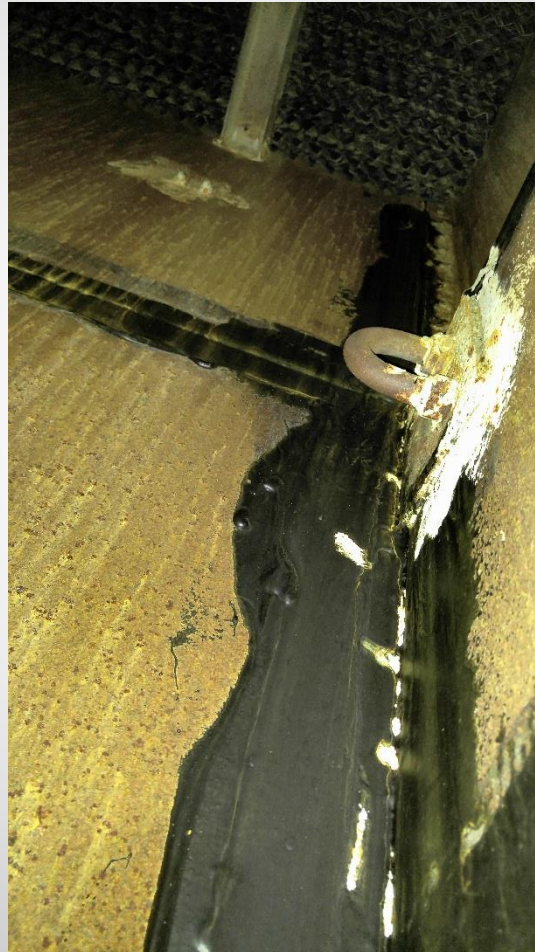
# SEAMS

APPEARS TO HAVE BEEN SEALED – NEED TO CONFIRM IF CURRENTLY LEAKING

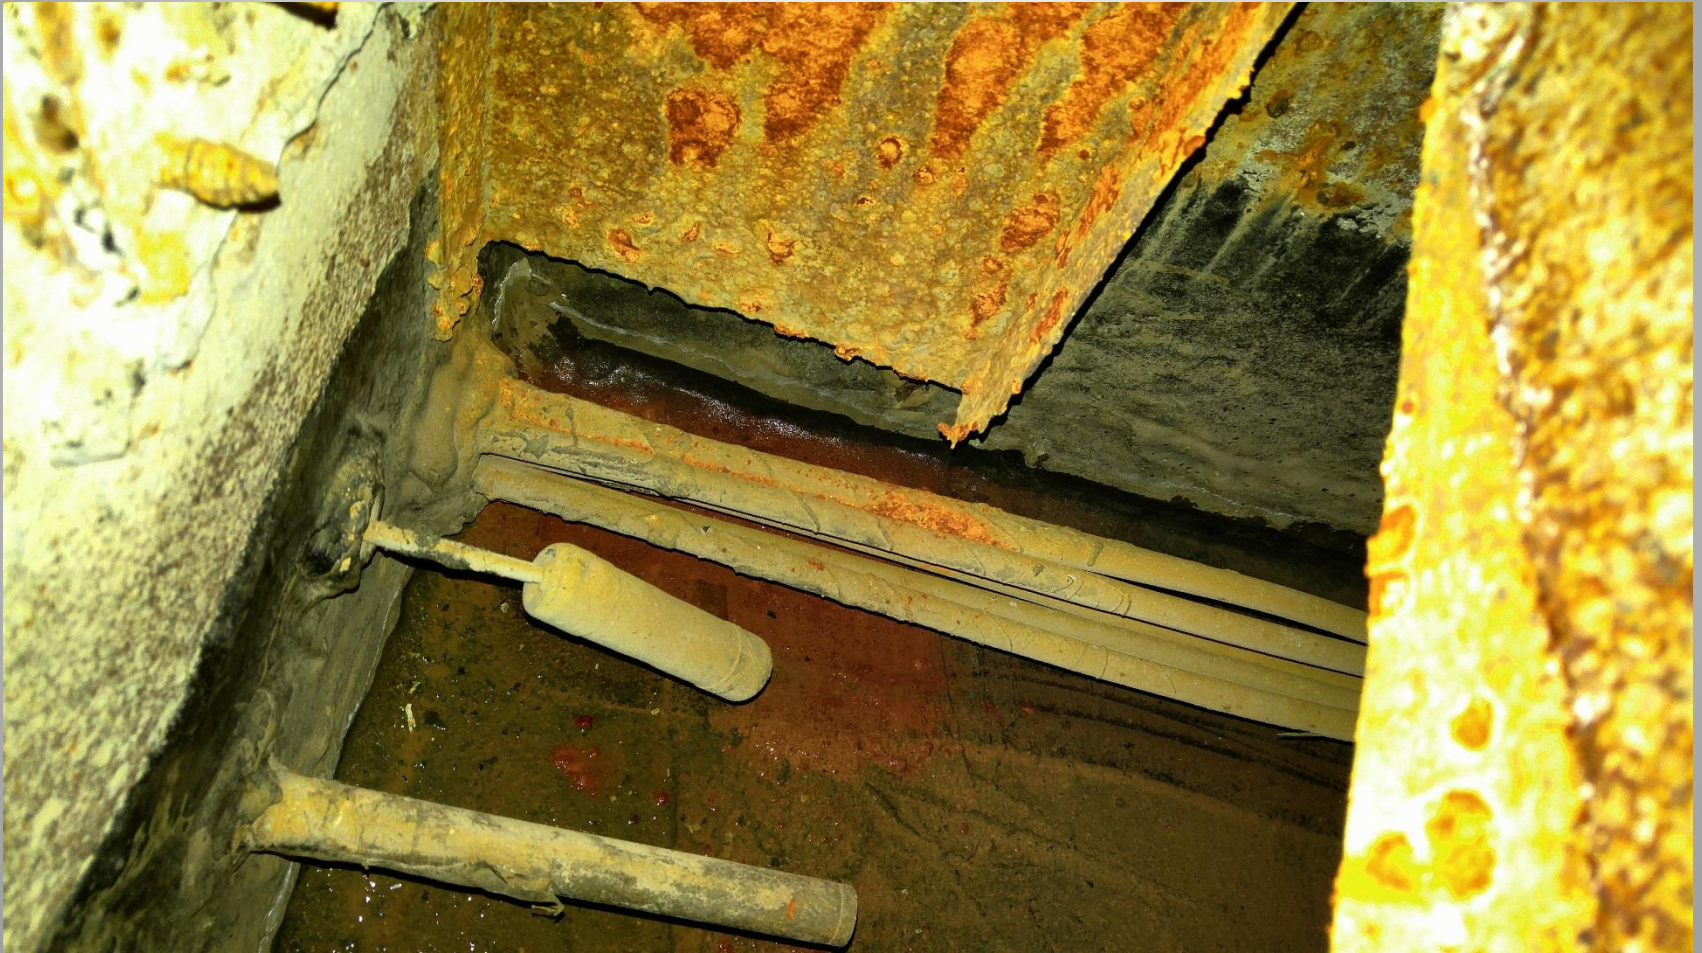
# SCALE BUILD UP

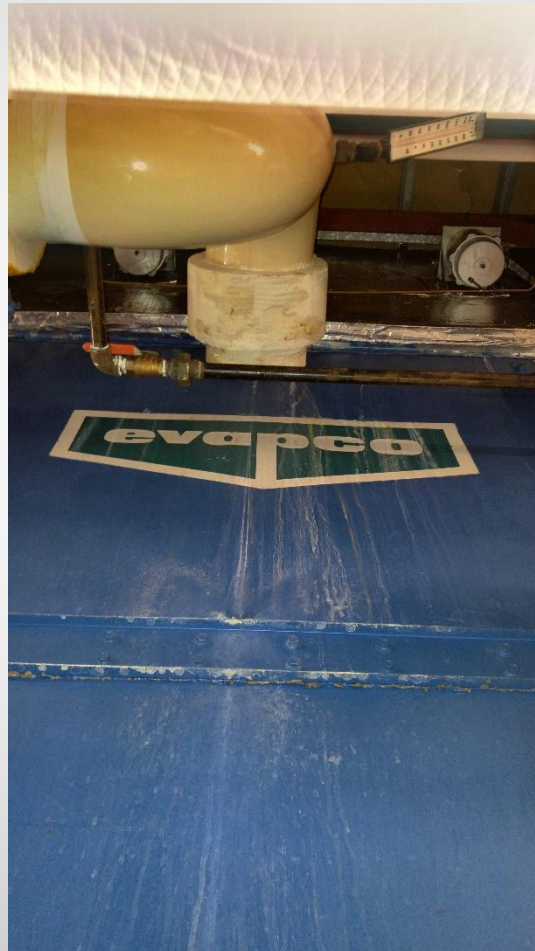
# LEAK

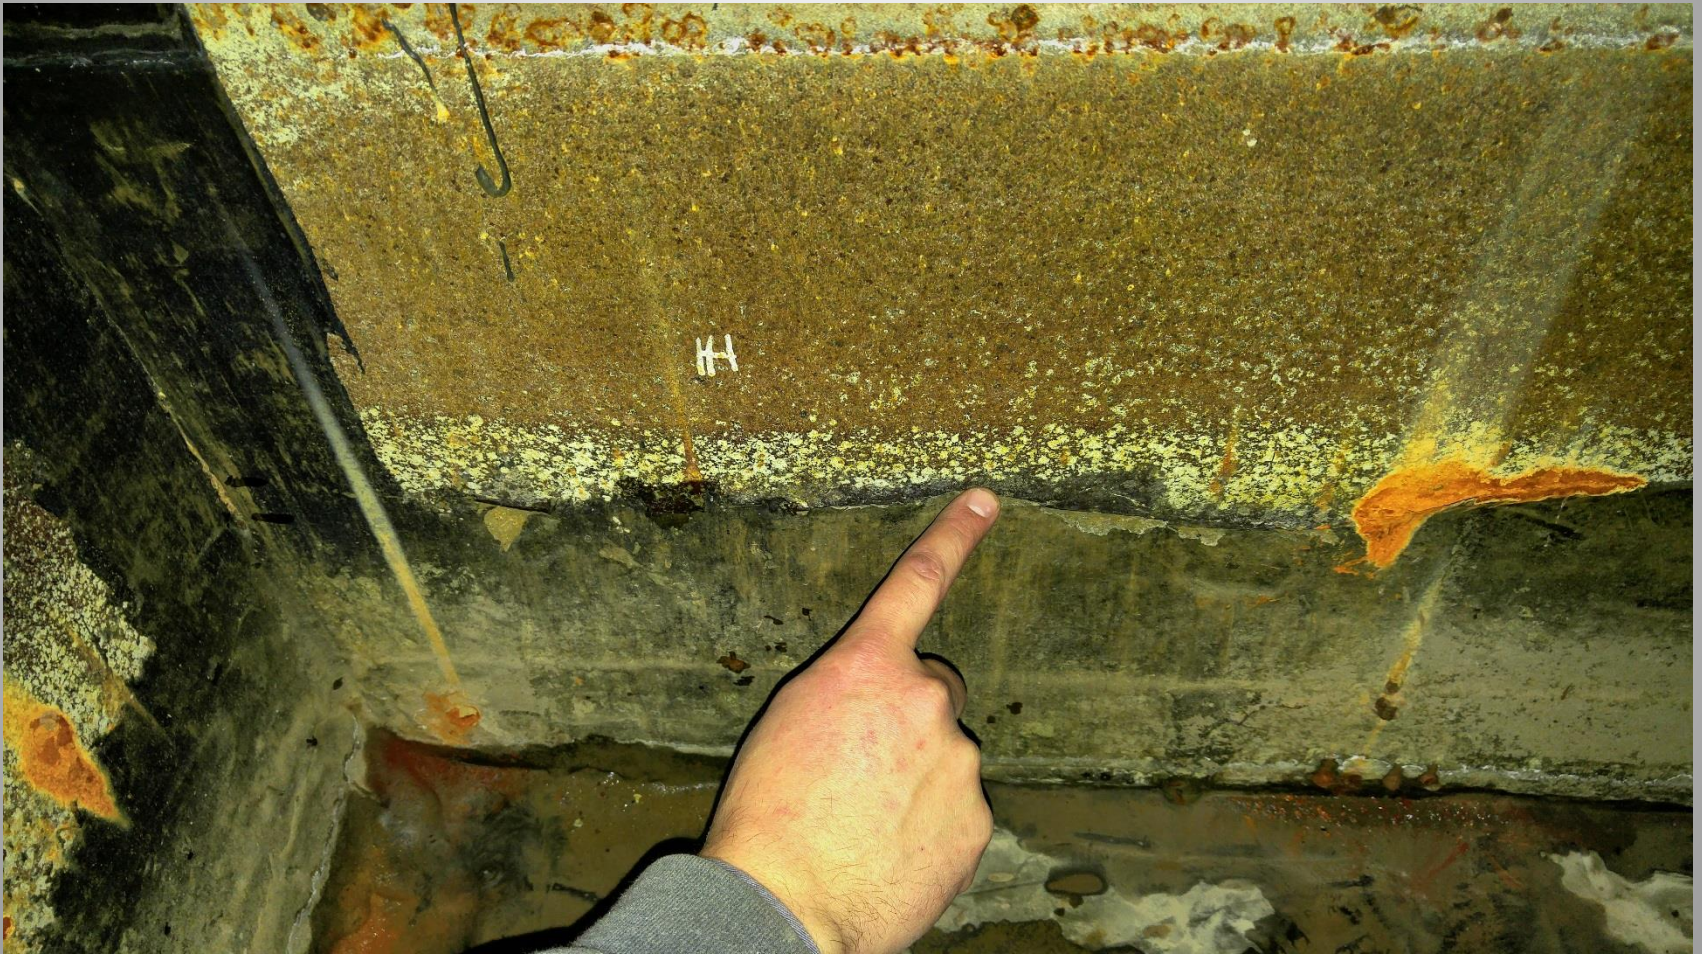
# LINER

## PEELING

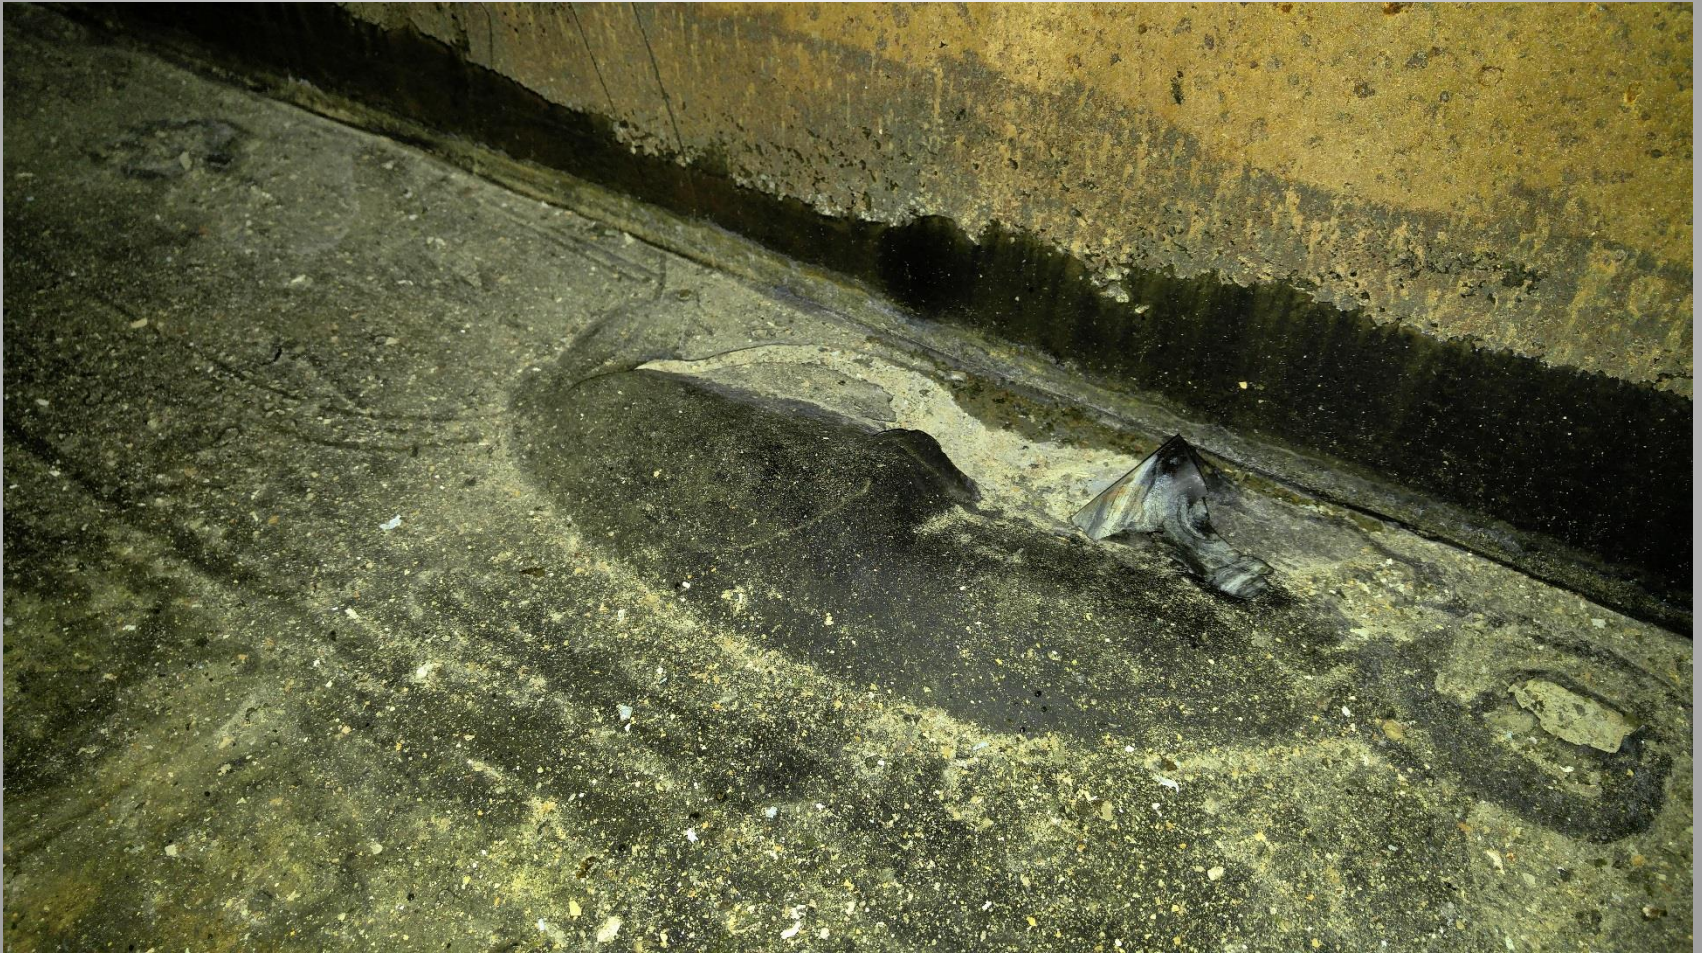
# LINER

## PEELING

- Towers were not running during inspection – current leaks were not able to be inspected.
- Appears sealing and patching in the past was attempted. The liner installed previously is peeling and is no longer effective.

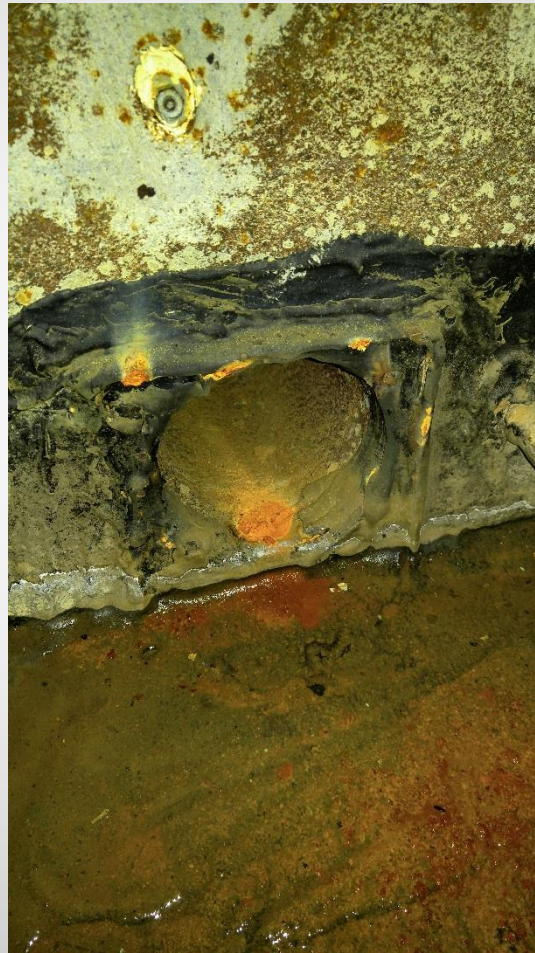
# SUCTION INLET

MISSING STRAINER
