# TOWER ASSESSMENT REPORT

PREPARED BY: MAC-TOWER INC  
15-1201 GRASSMERE RD  
WEST ST. PAUL, MANITOBA  
R4A 1C4

# **EVAPCO – COOLING TOWER 1**

## EVAPCO – COOLING TOWER 2

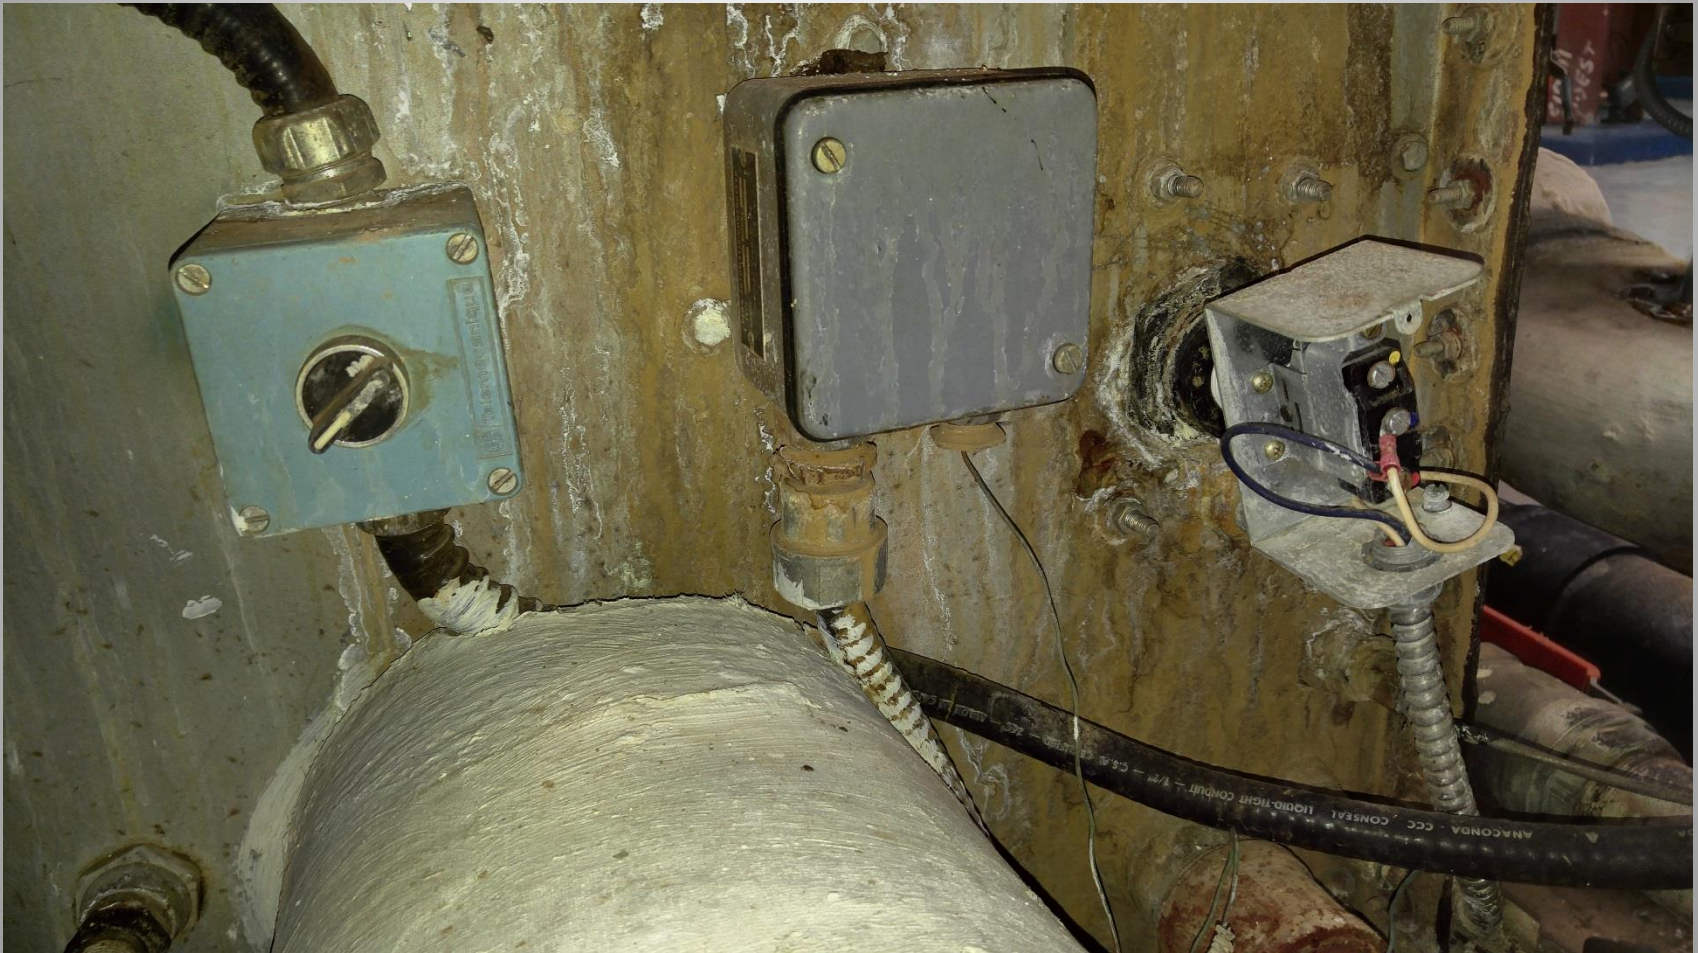
# ELECTRONIC WATER LEVEL CONTROL & HEATER CONTROLS

- Sump heater in both towers are not working.
- Suction strainers are missing and need to be replaced.
- Electronic Water Level Control is broken in both towers.
- The overall poor condition of the Fill, Eliminators, and Water Distribution has considerably reduced the Thermal Performance of this cooling tower.

- Clean or replace header section, and replace eliminators, fill and nozzles.
- Repair leaks at panel seams, bolts, and collars while fill and headers are removed for replacement.
- Replace discharge air damper section.
- Replace blower section.
- Evap-Line or replace entire cold water basin and install new strainer and supports.
- Replace electronic water level control.
- Replace sump heater and controls.

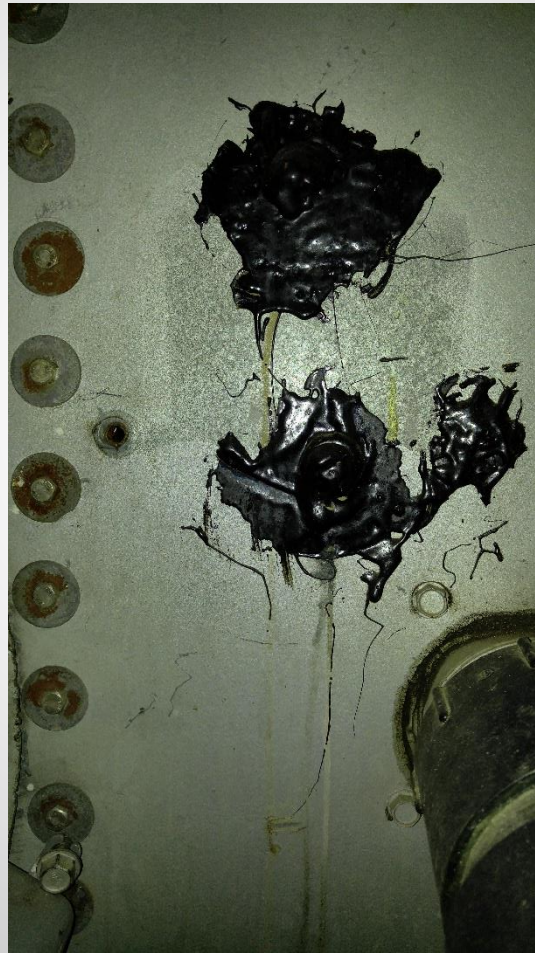
# SEAL

OLD LOCATION OF HEATER CONTROL

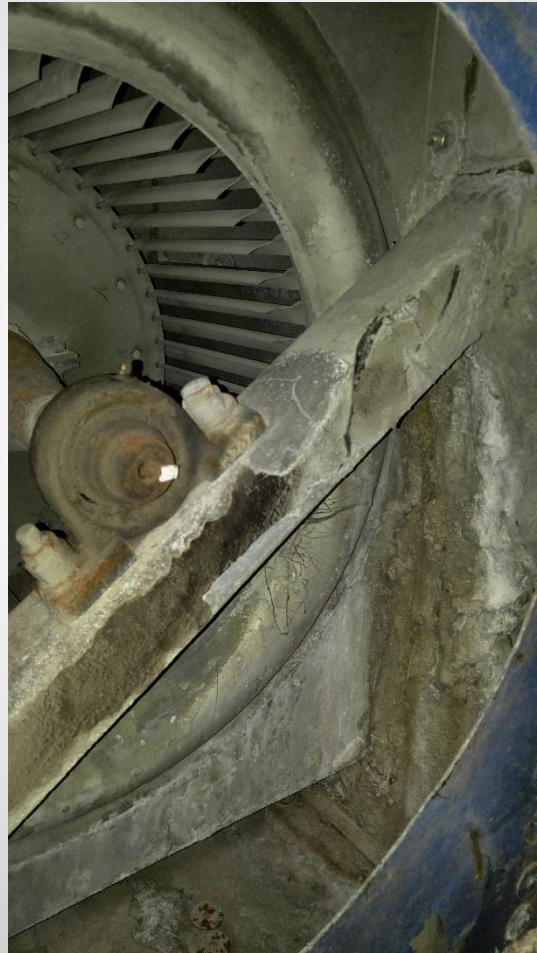
# BLOWER SECTION

- Discharge louvers are missing.
- Seam leaks in the blower section.
- Over all condition of blower section is satisfactory, but is worth replacing while other upgrades are taking place.
